UNITED STATES COAST GUARD

TUG VALOUR

40 MILES OFF THE COAST OF WILMINGTON, NORTH
CAROLINA ON JANUARY 18, 2006 WITH MULTIPLE
LOSS OF LIFE

Subj: TUG VALOUR REPORT OF INVESTIGATION

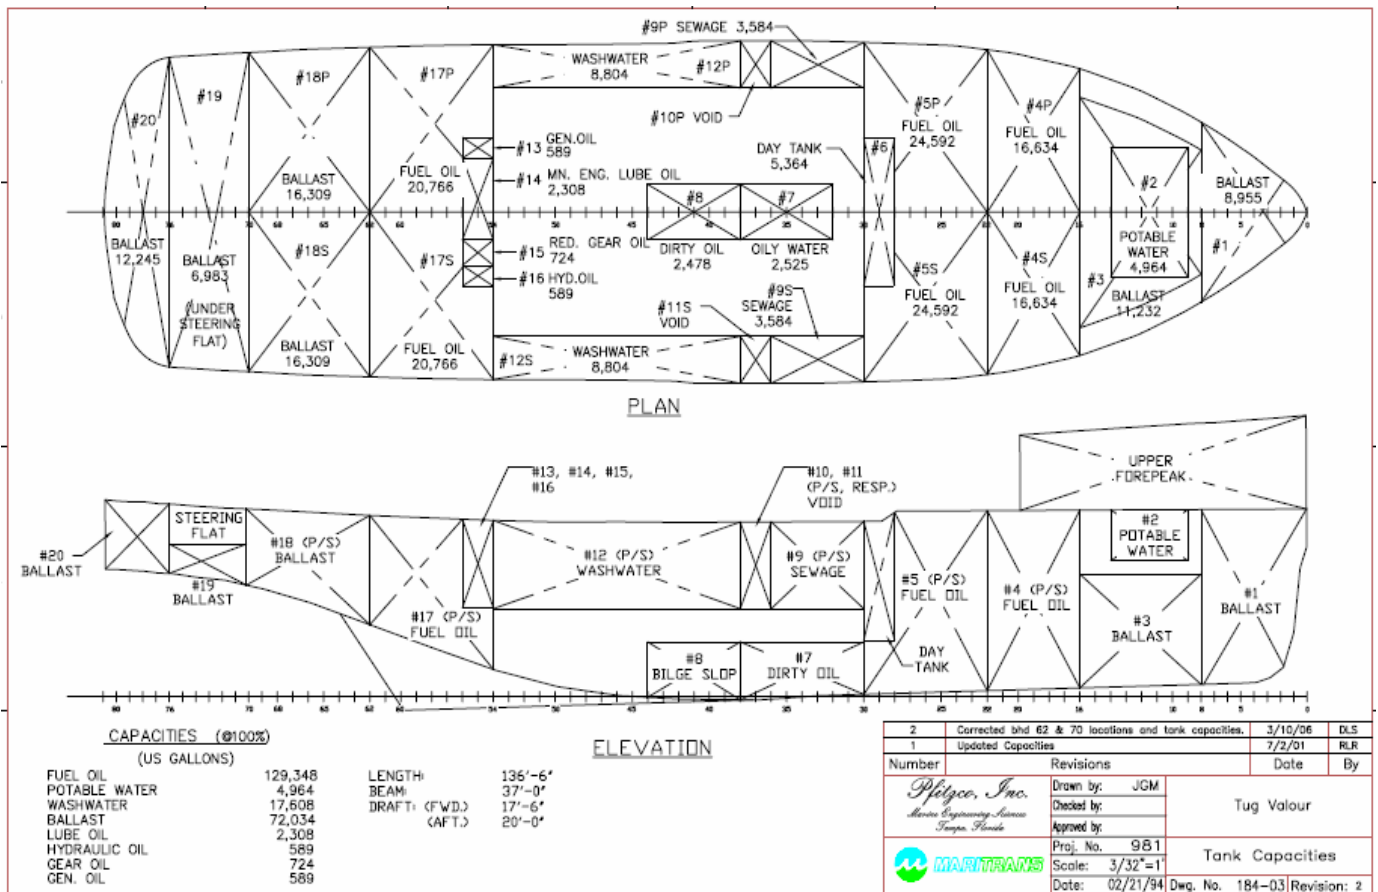
Corrected Tank Capacities Plan

5. The master and crew of the VALOUR relied on an incorrect tank capacity plan provided by Maritrans Operating Company, LP, the operating company of the VALOUR, for referencing tank capacities for ballasting and fueling. This plan dated February 21, 1994, had the #17 port and starboard fuel tank capacities at 15,683 gallons each and the #18 port and starboard ballast tank capacities at 8,483 gallons each. The Coast Guard received a corrected tank capacity plan after the VALOUR sank. The corrected capacities for the #17 fuel tanks were 20,766 gallons each and the #18 ballast tanks were 16,309 gallons each.

10. It is recommended that OSG – Maritrans conduct an internal review to ensure that all of their vessels' plans are accurate and up to date.
11. It is recommended that OSG – Maritrans revise their crew changeout checklist to ensure each crewmember verifies that they have a survival suit that fits him or her in a logical location such as in their stateroom, workplace or the emergency gear locker.

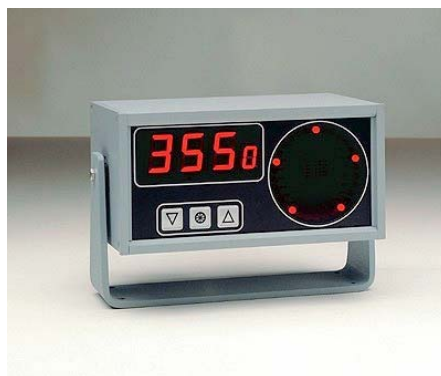
LR40 (same gyro digital display unit found on the VALOUR)

3. *Loss of Gyro / Maneuvering:* The wind was at least 40-50 knots gusting up to 70 knots and the seas ranged from 12 to 20 feet. Both were coming from approximately 180 degrees true. At 2320, Capt [REDACTED] slowed the VALOUR to 3 knots and shifted from autopilot to manual steering. At 2347, Capt [REDACTED] reported that he lost his gyro and that he was steering 103 degrees true according to the digital display. In his testimony he restated that the gyro did not fail. The digital display for the gyro was what he was referring to when he said he lost his gyro. Technical representatives for the gyro digital display (the LR40 shown below) stated that it has two alarm modes; the "Signal Alarm from Gyro Compass" and the "Power On Alarm." With the "Signal Alarm from Gyro Compass," the LR40 senses something wrong with the gyro signal and starts flashing the display, but it does not re-set the numbers to zero. The ships heading will be accurately displayed; however, it has most likely lost a "decimal" update. This means that it only loses or gains 1/6 of a degree. With the "Power On Alarm," the LR40 must lose power completely. In this case, once the unit regains power, the display will flash, but the numbers reset to 000.0 and begin counting up or down with the gyro signal. Meaning, if the unit lost power and then regained power when the vessel is on a gyro heading of 090 degrees true, then 090 degrees true is displayed as 000.0, 095 degrees true would be displayed as 005.0, 085 degrees true would be displayed as 355.0, and so on. When Capt [REDACTED] stated that the gyro display read 103 degrees; if this had been a "Power On Alarm," and Capt [REDACTED] was heading into the wind and seas (approximately 180 degrees true), then the VALOUR's gyro heading would have had to have been approximately 077 degrees true when the unit regained power in order for it to read 103. This is unlikely, as a course of 077 degrees true with a strong wind and sea coming from due south would have likely pushed the VALOUR much farther north.

Therefore, regardless of whether this is the result of maneuvering to locate the man overboard or a loss of spatial awareness, it is likely that the VALOUR was transiting on a course of 103 degrees true with a “Signal Alarm from Gyro Compass” causing the display to flash.

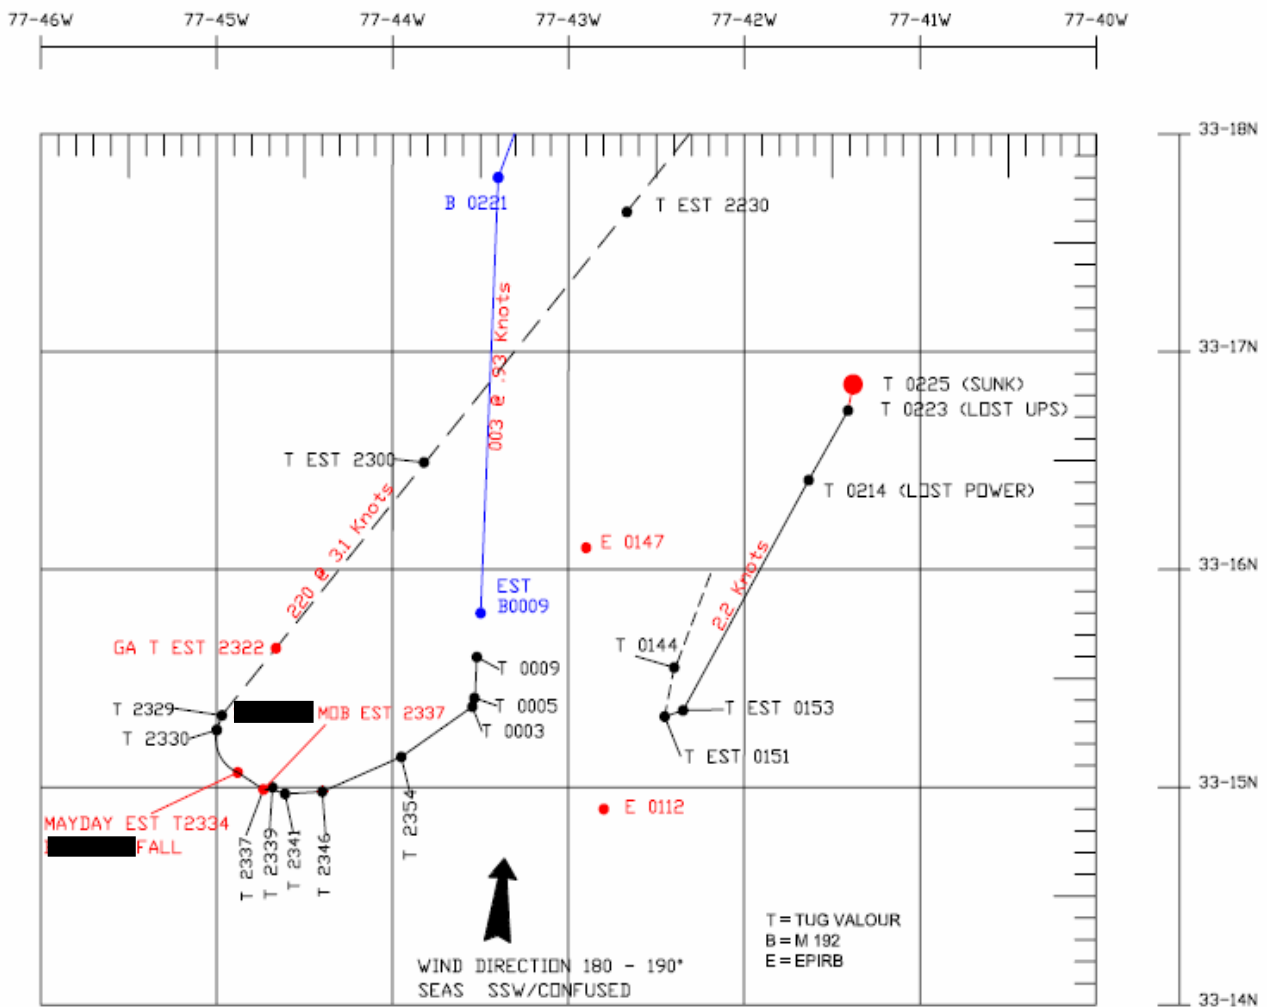
Tracklines of the VALOUR and Barge M192 (via transponders on each vessel)

The VALOUR's trackline shows that it began tracking to the east shortly after 2330, and from 2337 to 2346, was on a course made good of 093 degrees true. There is speculation as to what the VALOUR's heading was as Capt [REDACTED] stated that he was heading into the wind and seas. From 2330 to 2354, the VALOUR went a distance of approximately 1 nautical mile during the

24 minute timeframe on a course made good of 102 degrees true which could easily be accounted for on a course of 103 degrees true at 3 knots. It is however very unlikely that the VALOUR would drift 1 nautical mile east when she was heading into winds and seas coming from due south. The winds and seas coming from the south could not have had such an eastward effect on the VALOUR without a significant port heading change. Additionally, barge M 192 was being towed 500 yards behind the VALOUR and was subject to the same winds and seas. Once the tow was released, from 0009 to 0221, with only winds and seas exerting force upon it, the barge drifted on a course of 003 degrees true at approximately 1 knot.
