Investigation Report 34/16

Serious Marine Casualty

Grounding of the CSCL INDIAN OCEAN in the River Elbe on 3 February 2016

14 October 2016

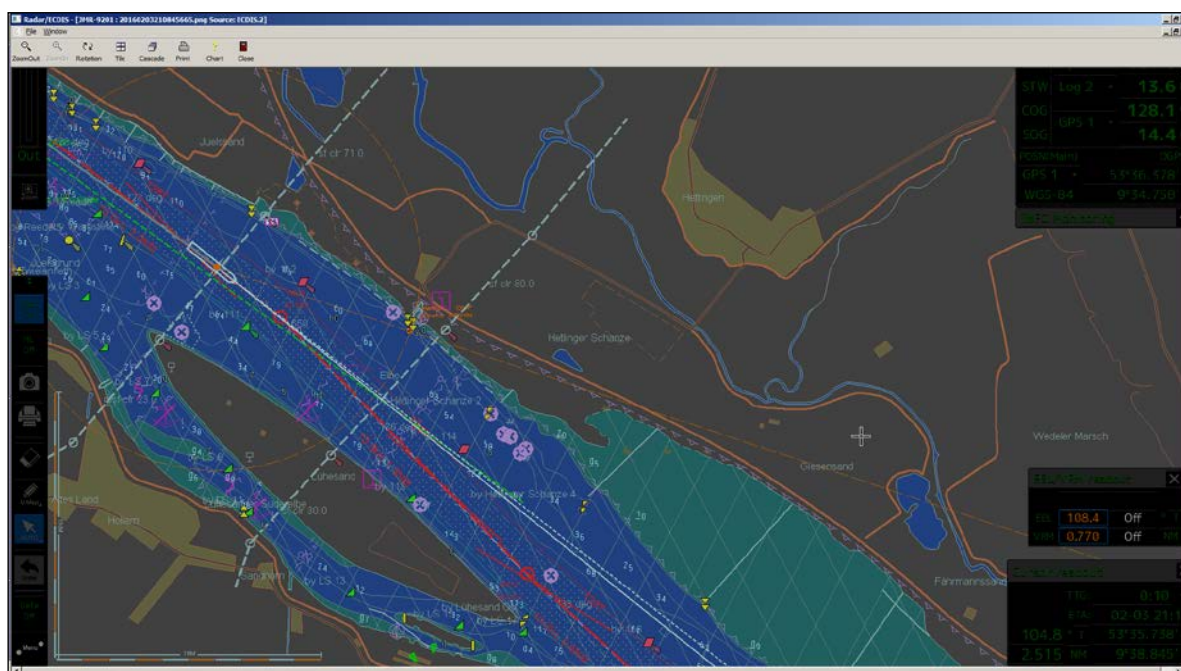
Figure 6: 220851 – passage of the first high-voltage power line starts

The recorded ECDIS data show clearly that the large container ship passed the first of two high-voltage power lines at Lühesand shortly before the first audible alarm on the bridge. The nautical chart shows that the clearance between water surface and high-voltage power line is 80 m at medium tide height. Since the height of the CSCL INDIAN OCEAN is approximately 69.0 m (including antenna system on the observation deck), a height of approximately 56.9 m remains above the waterline when the current draught of 12.1 m is subtracted. This means that the clearance to the high-voltage power line is approximately 23 m. In the opinion of experts consulted by the BSU, this clearance is wholly adequate, meaning that an electromagnetic effect on the ship's technical installations can be ruled out and that the present case was a random convergence of events (see Figure 6 and Figure 7).

It was not possible to find any correlation in the fact that the helm failed when the high-voltage power line was passed. It is quite reasonable to rule out any influence because no traces of a short circuit or fire were detected.

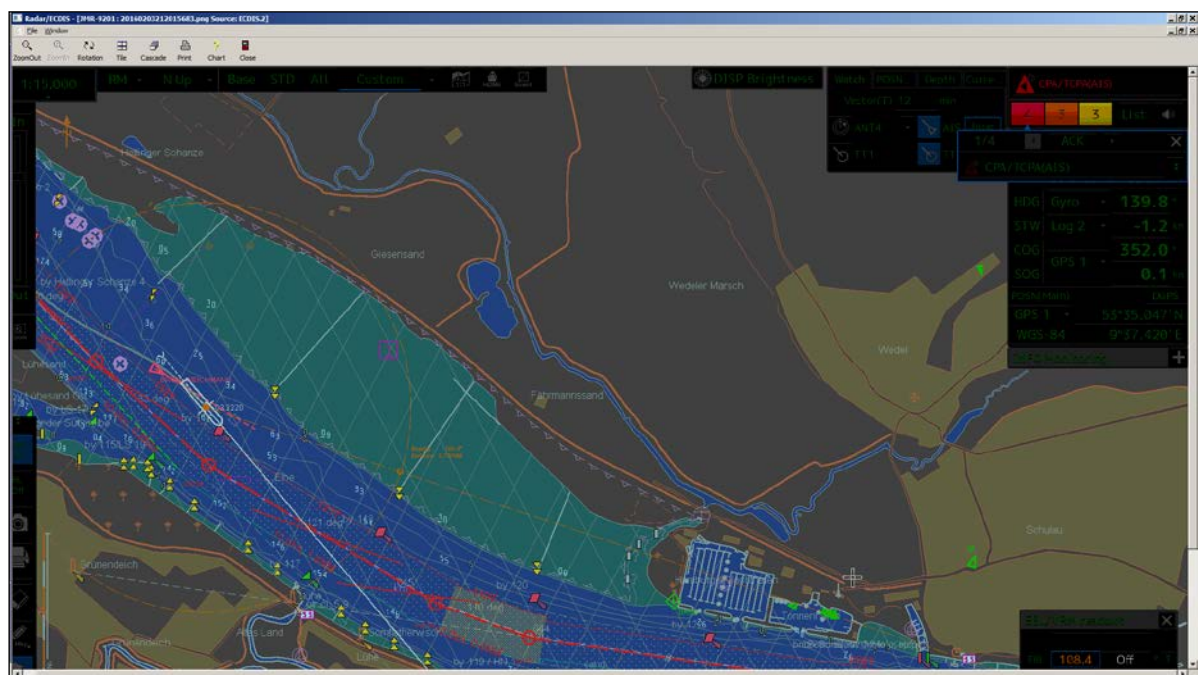
Figure 12: 222010 – grounded: SOG = 0.1 kt

The GPS devices indicate a speed over ground (SOG) of NULL at 222010. The CSCL INDIAN OCEAN's fore section has run aground on the port side.

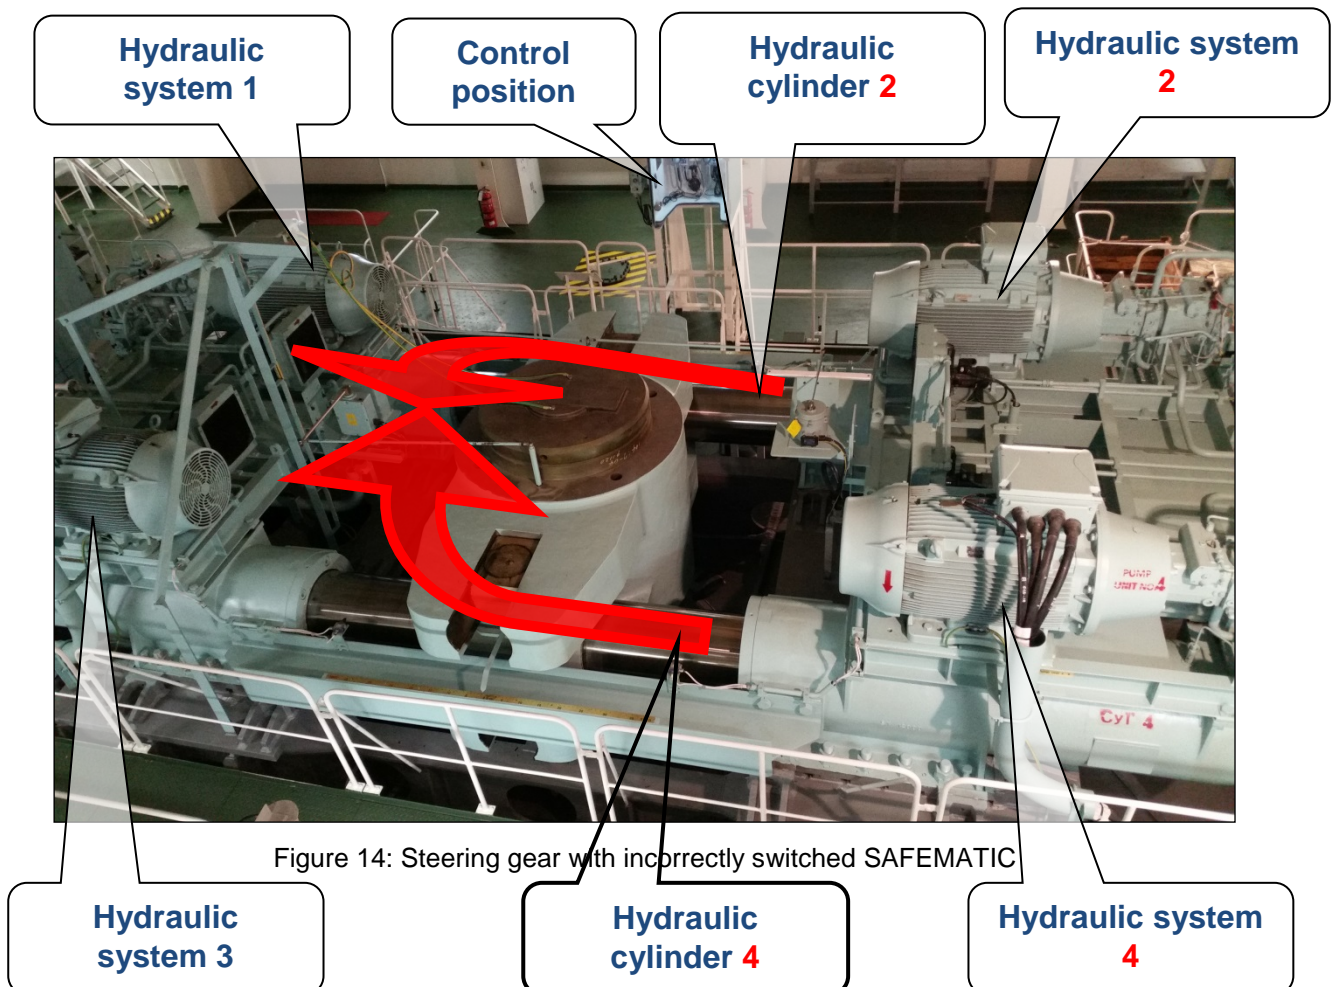
Figure 14: Steering gear with incorrectly switched SAFEMATIC

To check the SAFEMATIC, the test switch at the switch cabinet was pressed (see Figure 15). As expected, two of the four hydraulic units then switched off. The helm failed to respond to any command, however. Following that, each valve was then switched on and off systematically by hand until the helm finally responded. This revealed that the SAFEMATIC was switched incorrectly in that as well as hydraulic cylinder 2 being operated, as intended, hydraulic cylinder 4 was also operated. Regrettably, this was such that both cylinders pressed on the rudderstock simultaneously in the same direction, meaning the rudder was unable to turn. The load on the rudder's mounting was enormous (see Figure 14).

Figure 22 shows the same chart. This shows how the incorrectly connected cables found affect the hydraulic fluid's routing. Under these conditions, the SAFEMATIC valve 2 is inactive, while 1 opens. Accordingly, valve 2 allows the flow of oil up to valve block 1 on the port side, where a valve that builds a connection back to valve block 2 is thus opened. A hydraulic short circuit is created, which causes cylinders 2 and 4 to activate, meaning they block each other mutually. The rudder is now unable to move. Instead, extremely large forces now act on the rudder's mounting.

The Federal Bureau of Maritime Casualty Investigation recommends that the owner inspect sister ships to determine whether their SAFEMATIC is also wired incorrectly and whether the cables of the hydraulic locking system also terminate at a switch cabinet.

The BSU recommends that the classification society broaden the periodic inspections of the SAFEMATIC to include the implementation of a helm manoeuvre in SAFEMATIC mode.

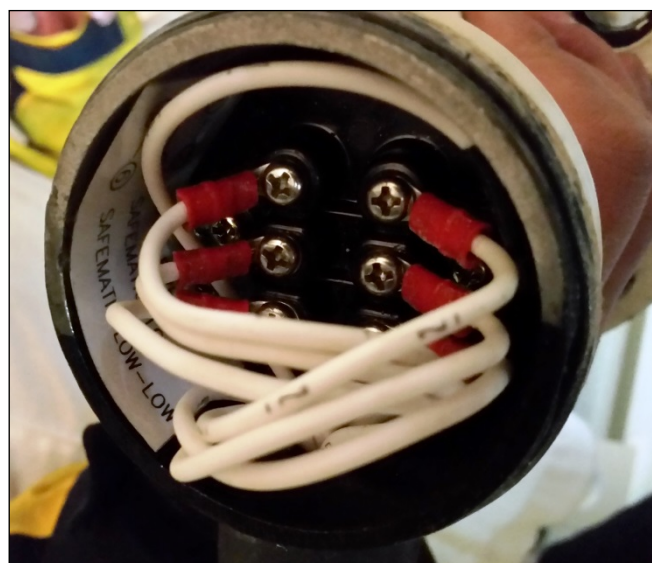
Figure 16: Float switch's contact panel

Since there was no evidence whatsoever of any leakage, it is reasonable to assume that there was no leakage in the hydraulic system. From this point, a float switch malfunction would be conceivable. The expert disassembled and tested this completely on behalf of the BSU on 11 February 2016. Figure 16 shows the clean contact panel of the float switch. No faults were found, however. The float switch operated as it should.

Alternatives 2 and 3 can be ruled out because according to witness testimony, no one was situated in the steering gear compartment.
No other alternative was found than a random malfunction of the float switch.
