Report on the investigation of heavy contact
with the quay and two shore cranes
by the UK registered container ship
CMA CGM Centaurus
at Jebel Ali, United Arab Emirates

4 May 2017

SERIOUS MARINE CASUALTY

REPORT NO 17/2018

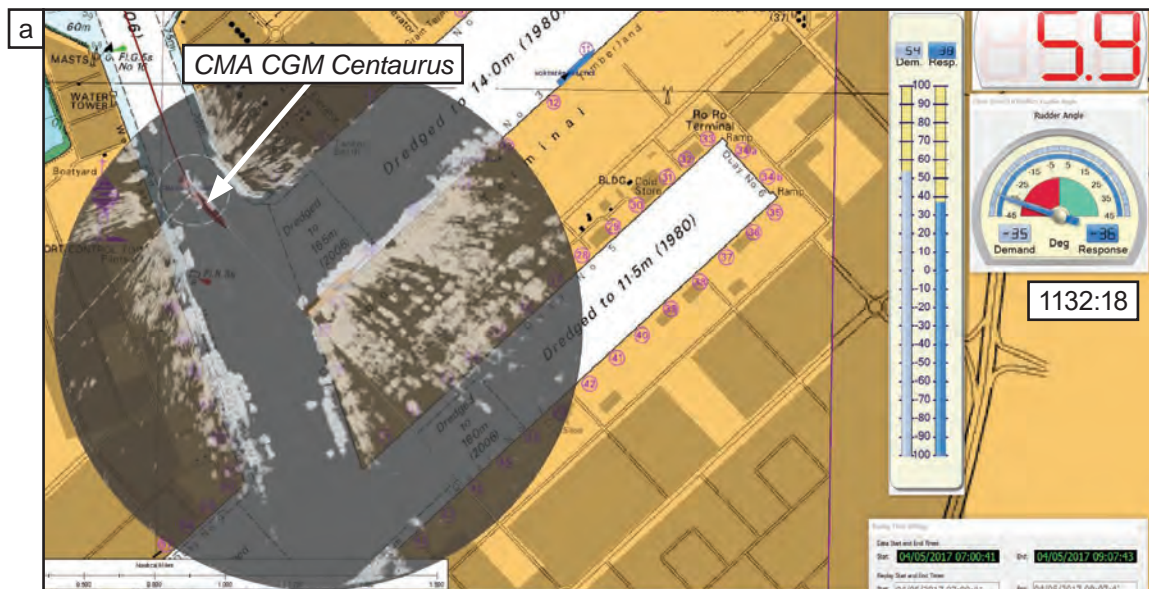
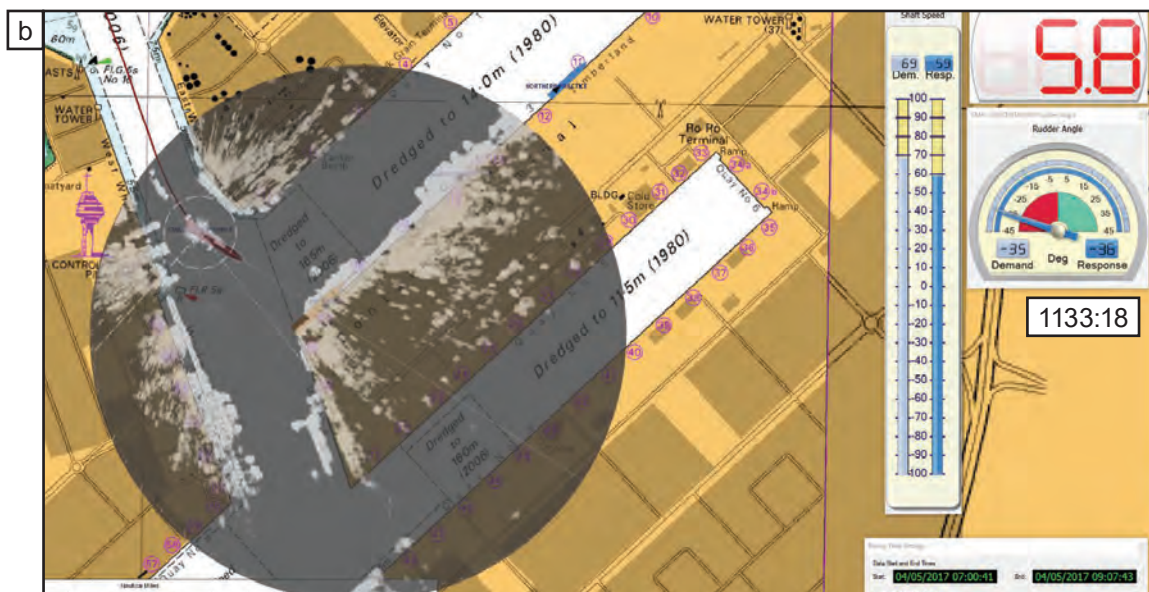
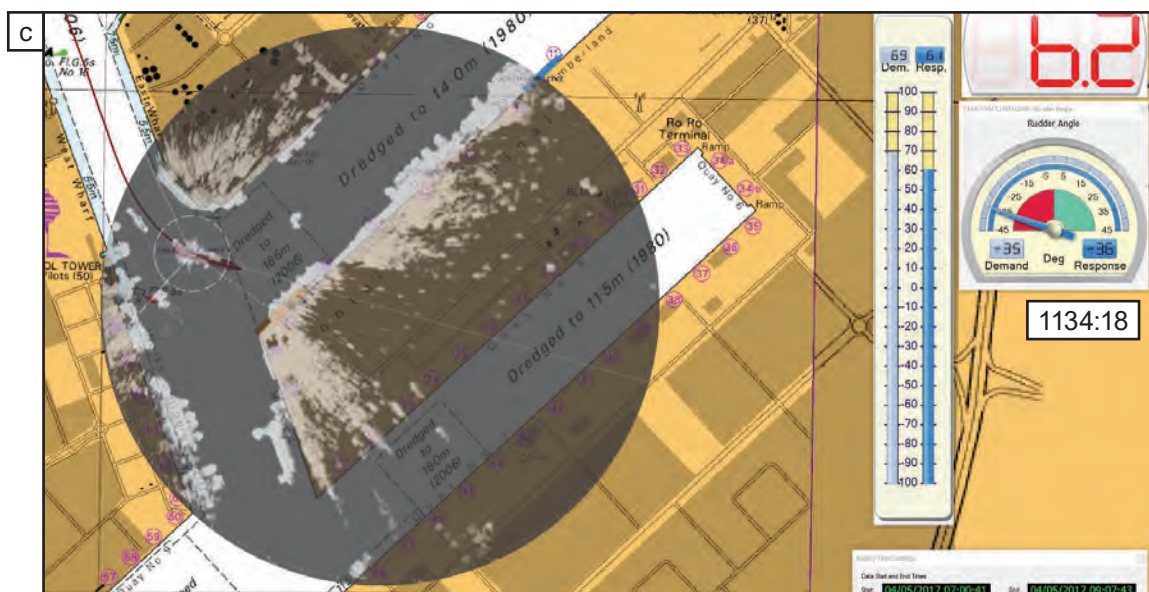
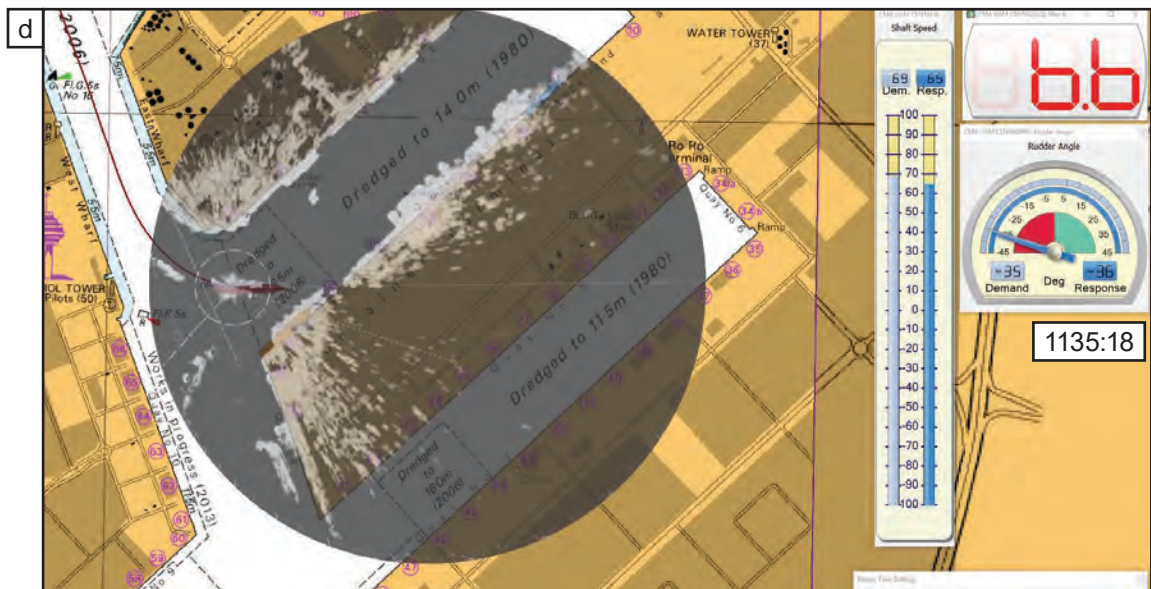
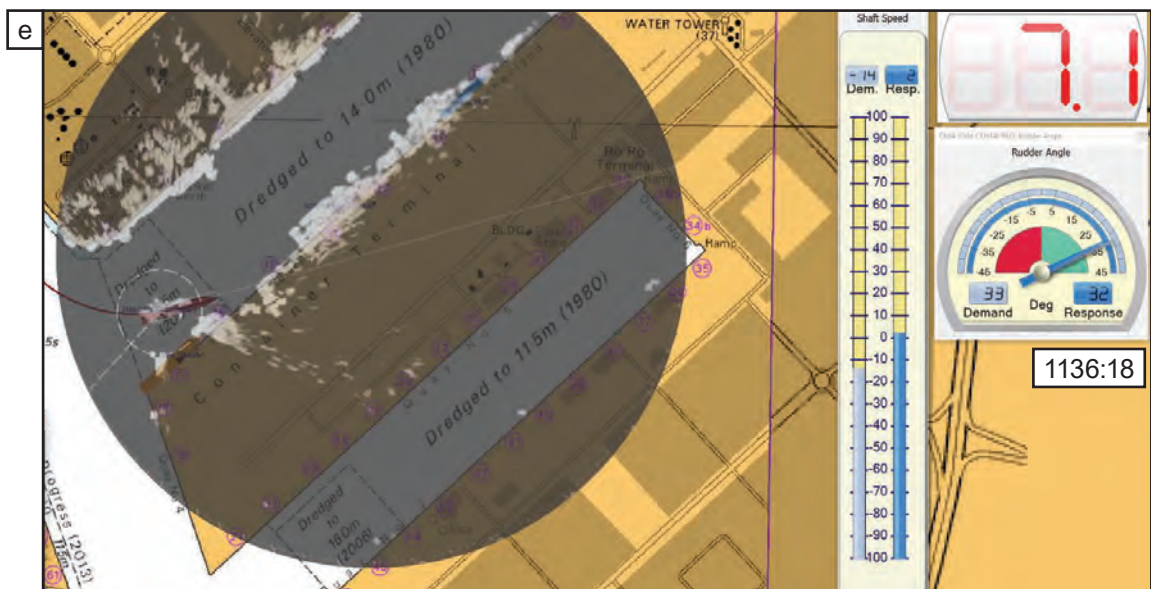
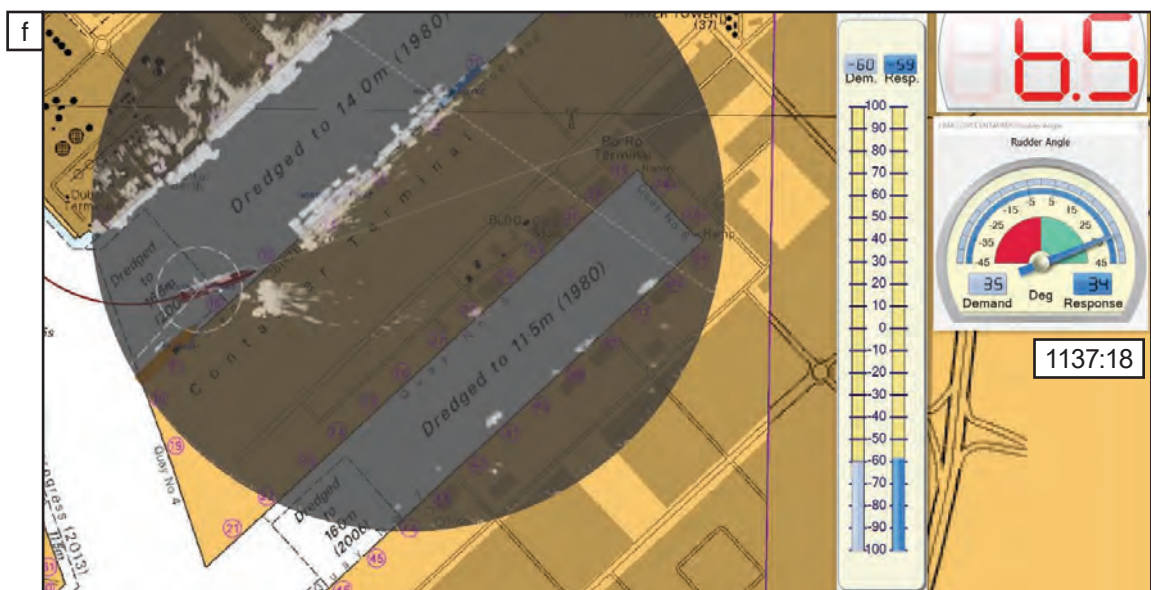
At 1135:20, with the second officer on the ship's forecastle reporting decreasing closing distances from *NYK Crane*, the pilot ordered 'hard to starboard'. The master stated "*This is no good*". He then called the engine room by telephone, advising of the need to prepare for an emergency manoeuvre. Meanwhile, the pilot instructed the tug *Timrar*'s skipper by VHF radio to "*immediately come on other side*".

Figure 5a-5c: Series of MADAS screenshots

Figure 5d-5f: Series of MADAS screenshots

The pilot then ordered 'stop engines', and then in quick succession 'slow astern', 'half astern' and 'full astern'. The pilot ordered 'amidships' and, 30 seconds later, 'hard to starboard', resulting in *CMA CGM Centaurus*'s stern clearing *NYK Crane*.

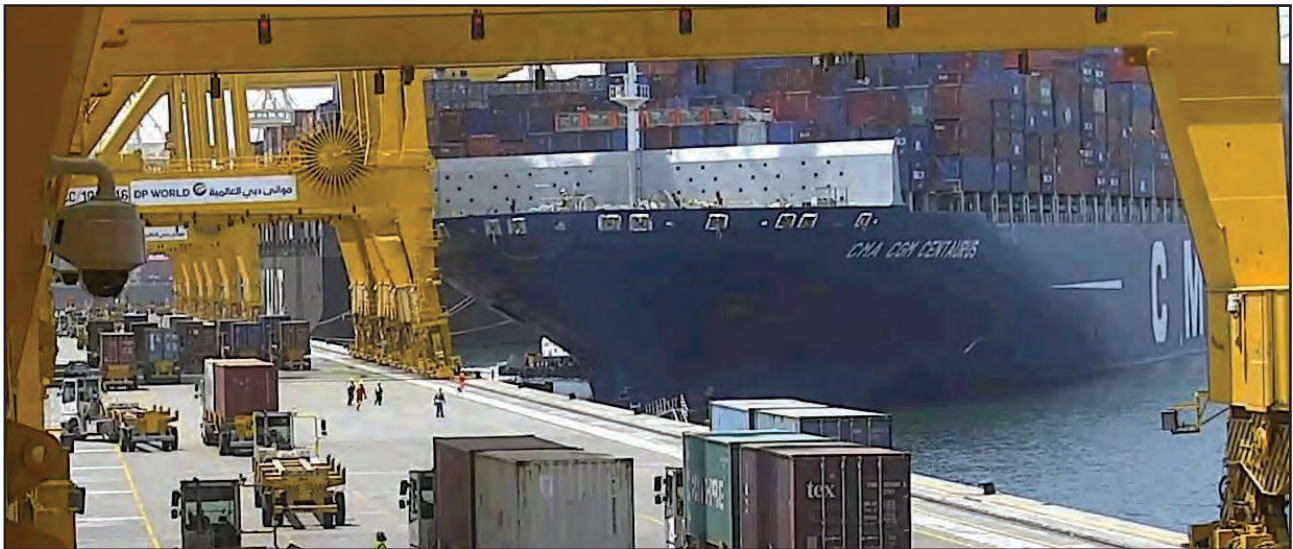
Figure 6: CMA CGM Centaurus making contact with the quay

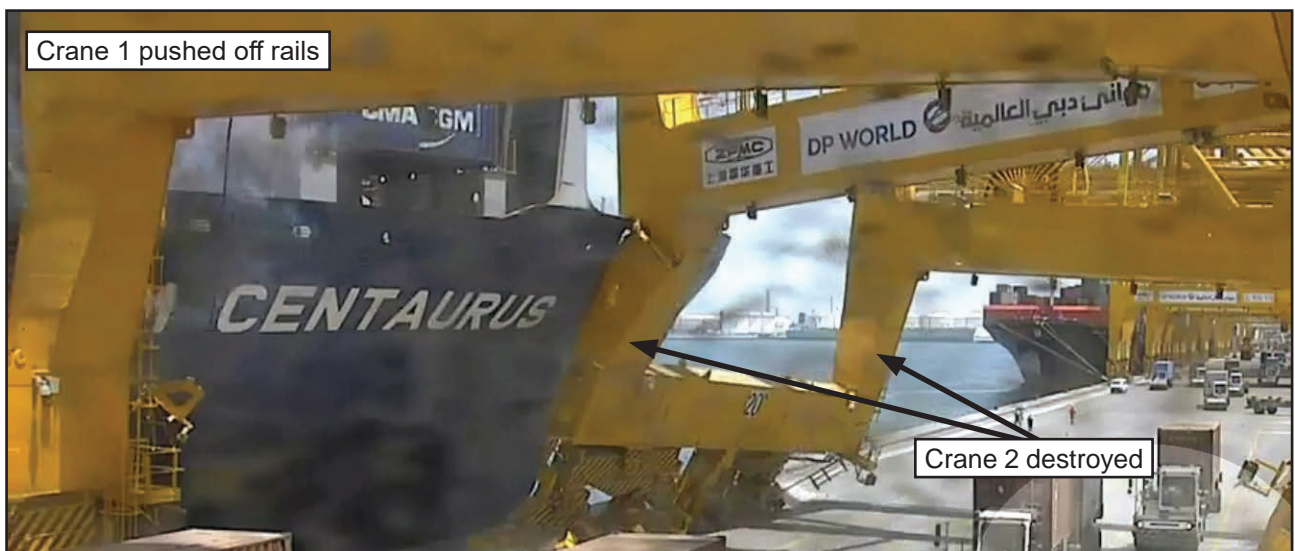
Two shore cranes were structurally damaged. One crane was removed from its tracks by the impact. The second crane collapsed completely, narrowly missing an occupied office building (**Figure 9**), which was structurally damaged as a result of the accident.

Figure 7: CMA CGM Centaurus making contact with two shore cranes

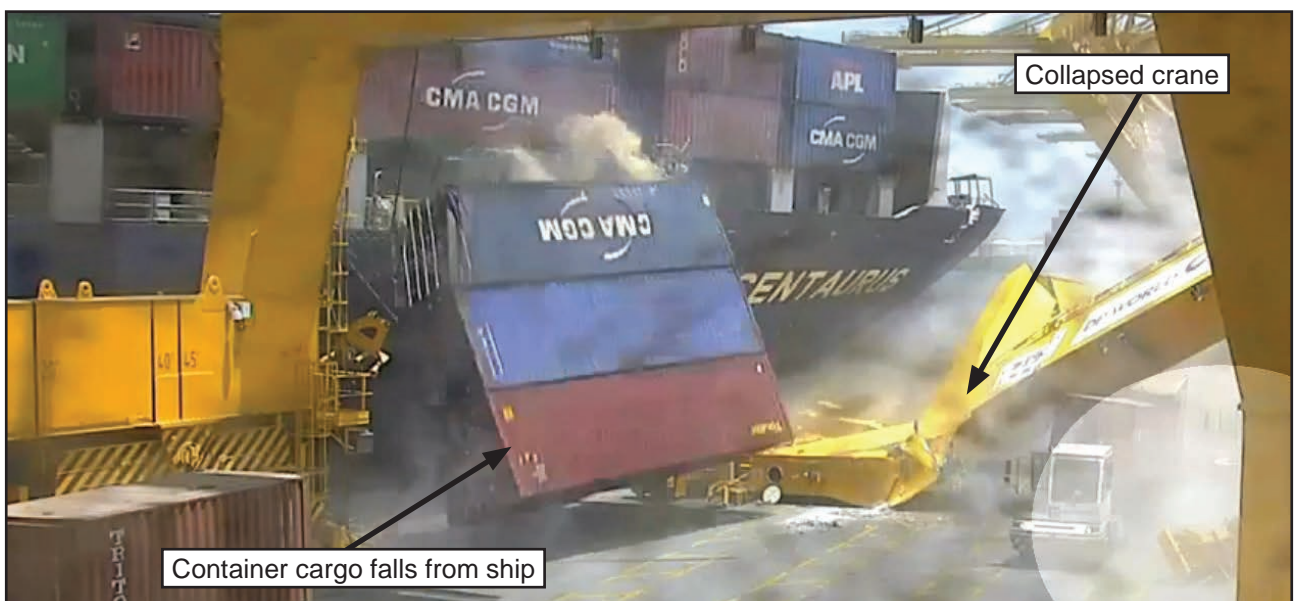
Figure 8: Containers falling from ship onto the quay

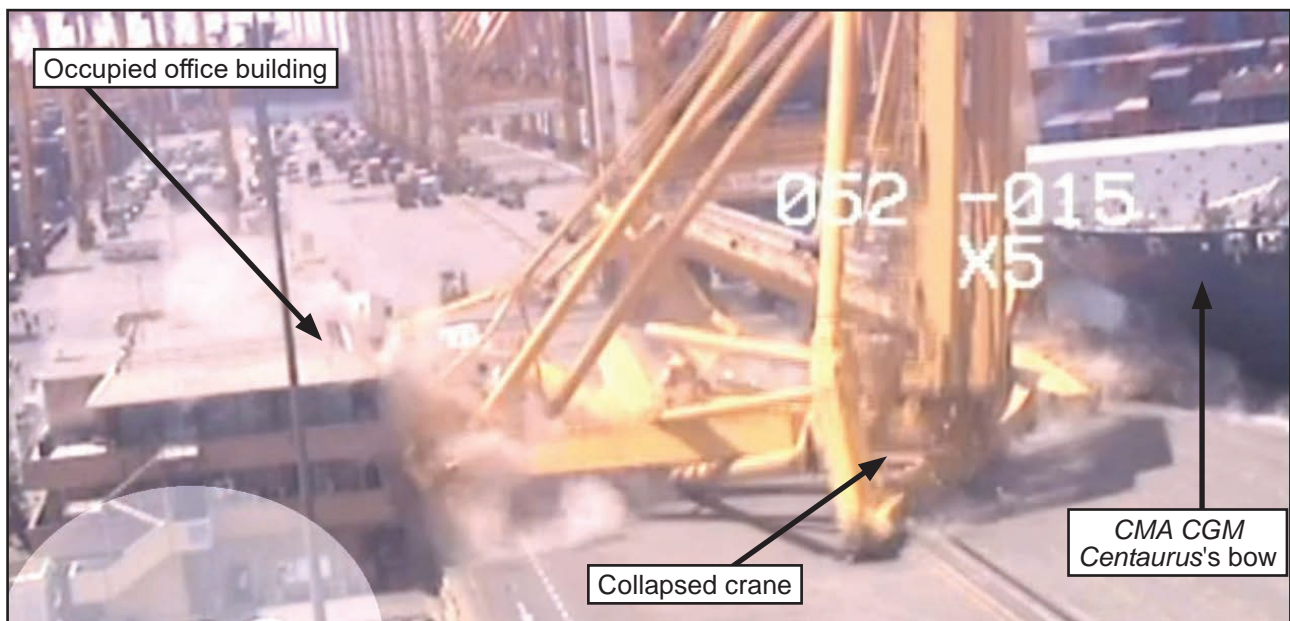
Figure 9: Crane collapsing in close proximity to an occupied office building
