Report on the investigation of the
groundings of
Ocean Prefect
Umm Al Qaywayn, United Arab Emirates
on 10 and 11 June 2017

On 10 June 2017, the UK registered bulk carrier *Ocean Prefect* grounded when approaching Ahmed Bin Rashid Port, in Umm Al Qaywayn, United Arab Emirates. The vessel was not damaged and refloated 12 hours later with tug assistance. It then anchored in safe water. On 11 June, the vessel again touched the sea bottom when entering the port, but was able to continue to its berth. However, on this occasion, three of *Ocean Prefect*'s ballast tanks were breached, which required the vessel to dry dock in Dubai for repair. Two harbour pilots were on board during the groundings. There was no pollution and no injuries.

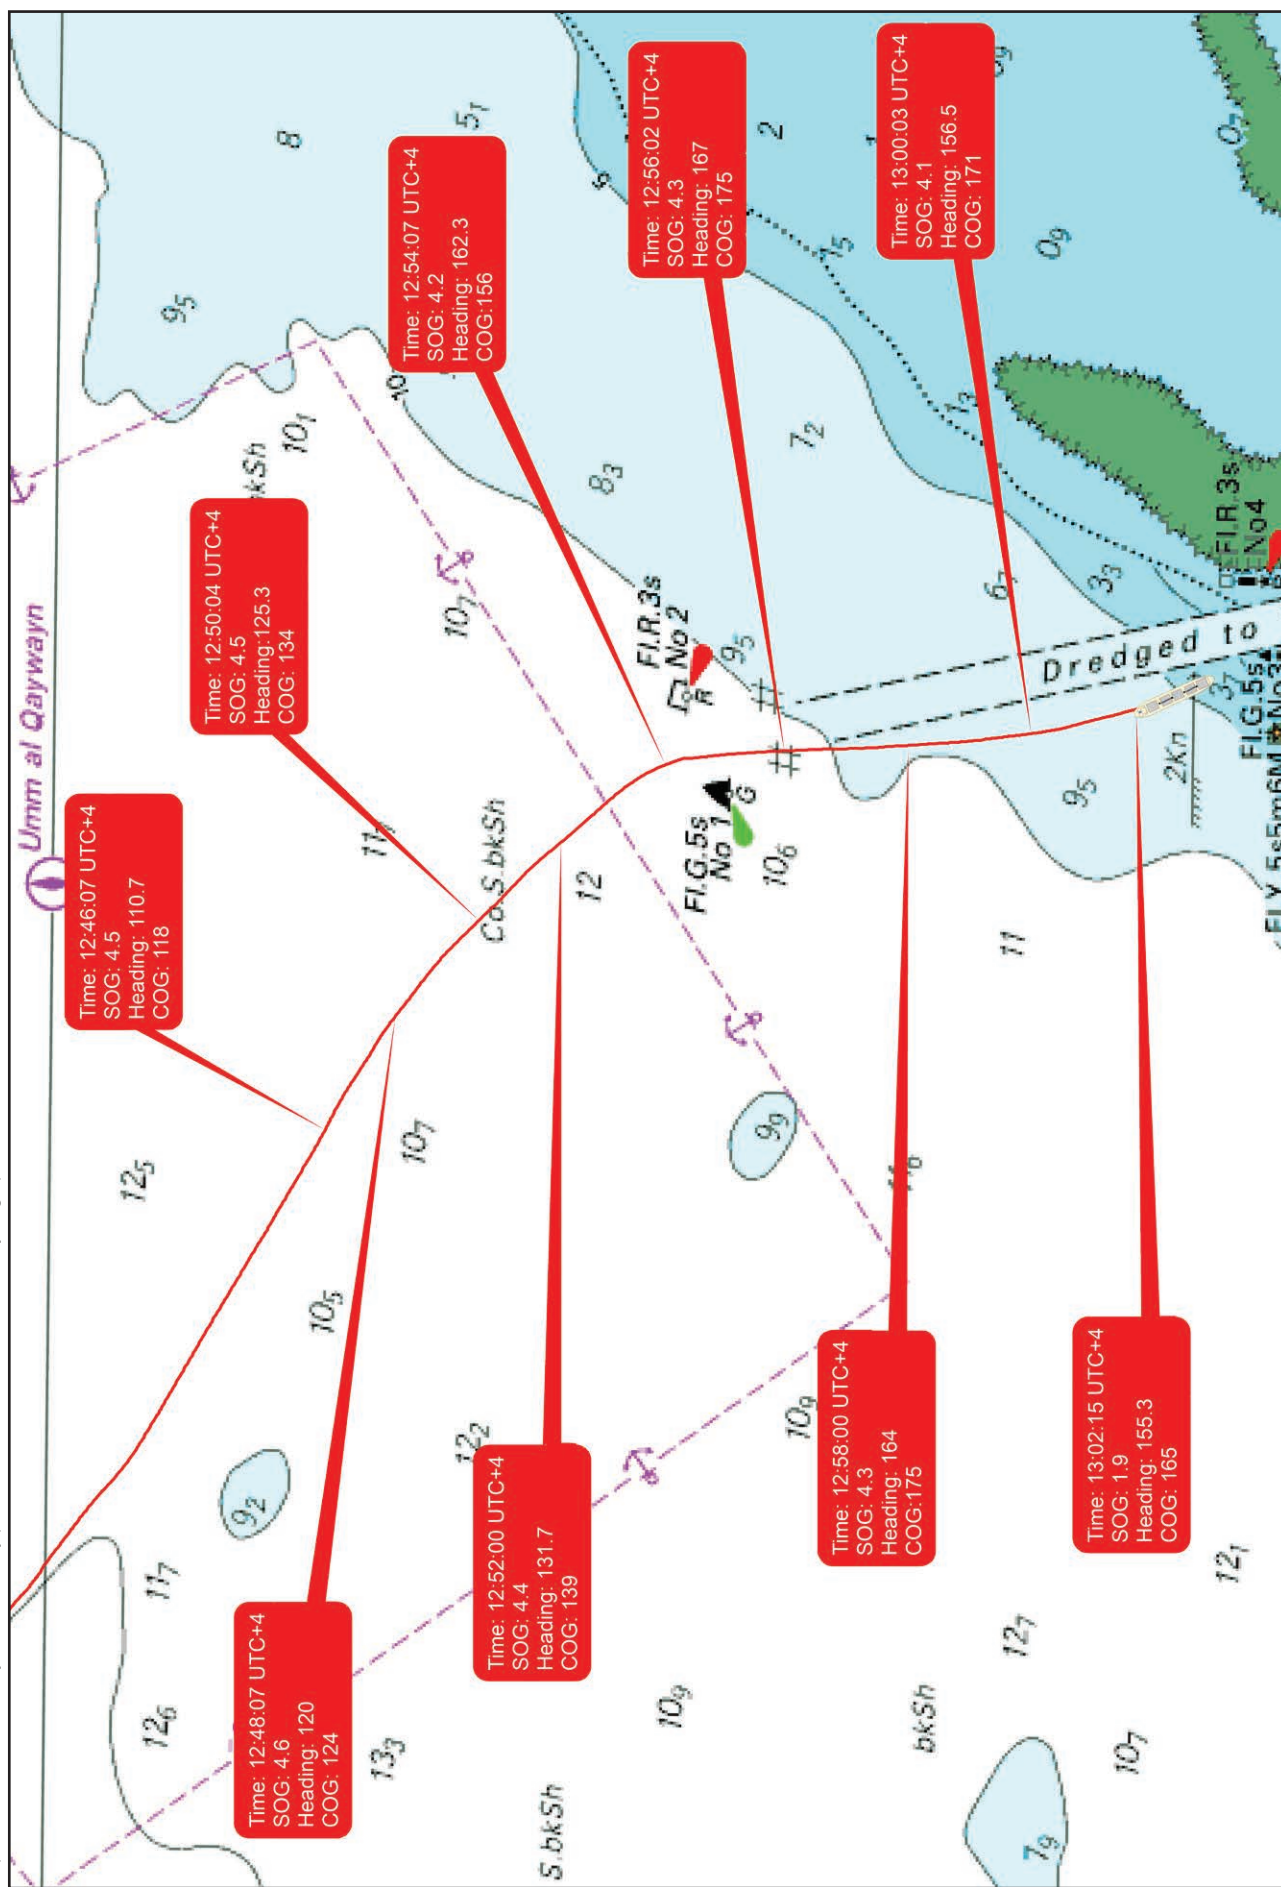
At 1254, *Ocean Prefect* passed between No.1 and No.2 buoys (**Figure 4**) and the pilot steadied the vessel on a heading of 167°. The engine telegraph was at 'slow ahead' and the vessel was making good 4.2kts⁵. At 1255:42, the echo sounder alarm activated. The depth displayed on the echo sounder, which was set to show 'depth below the keel', was 1.8m.

Figure 4: Extract of Admiralty Chart 3405 showing Ocean Prefect's track on 10 June 2017

That the pilot initially steadied *Ocean Prefect* on the channel axis of 167° indicates that he had not anticipated a tidal set. His later heading adjustments to 165° at 1256:10 and to 163° at 1257:26, which were only very minor alterations, and his enquiry regarding a gyro error, also indicate that he had not fully appreciated the cause or the extent of the set experienced. The pilot's perspective was influenced by an expectation that the tidal stream would be slack, as the entry was within 30 minutes of the predicted time of high water and he had detected only a slight set during the outbound passage on board *San Nicolas*. Consequently, his focus was on being able to stop the vessel in readiness for berthing, which is shown by the reduction from 'slow ahead' to 'dead slow ahead' at 1256.

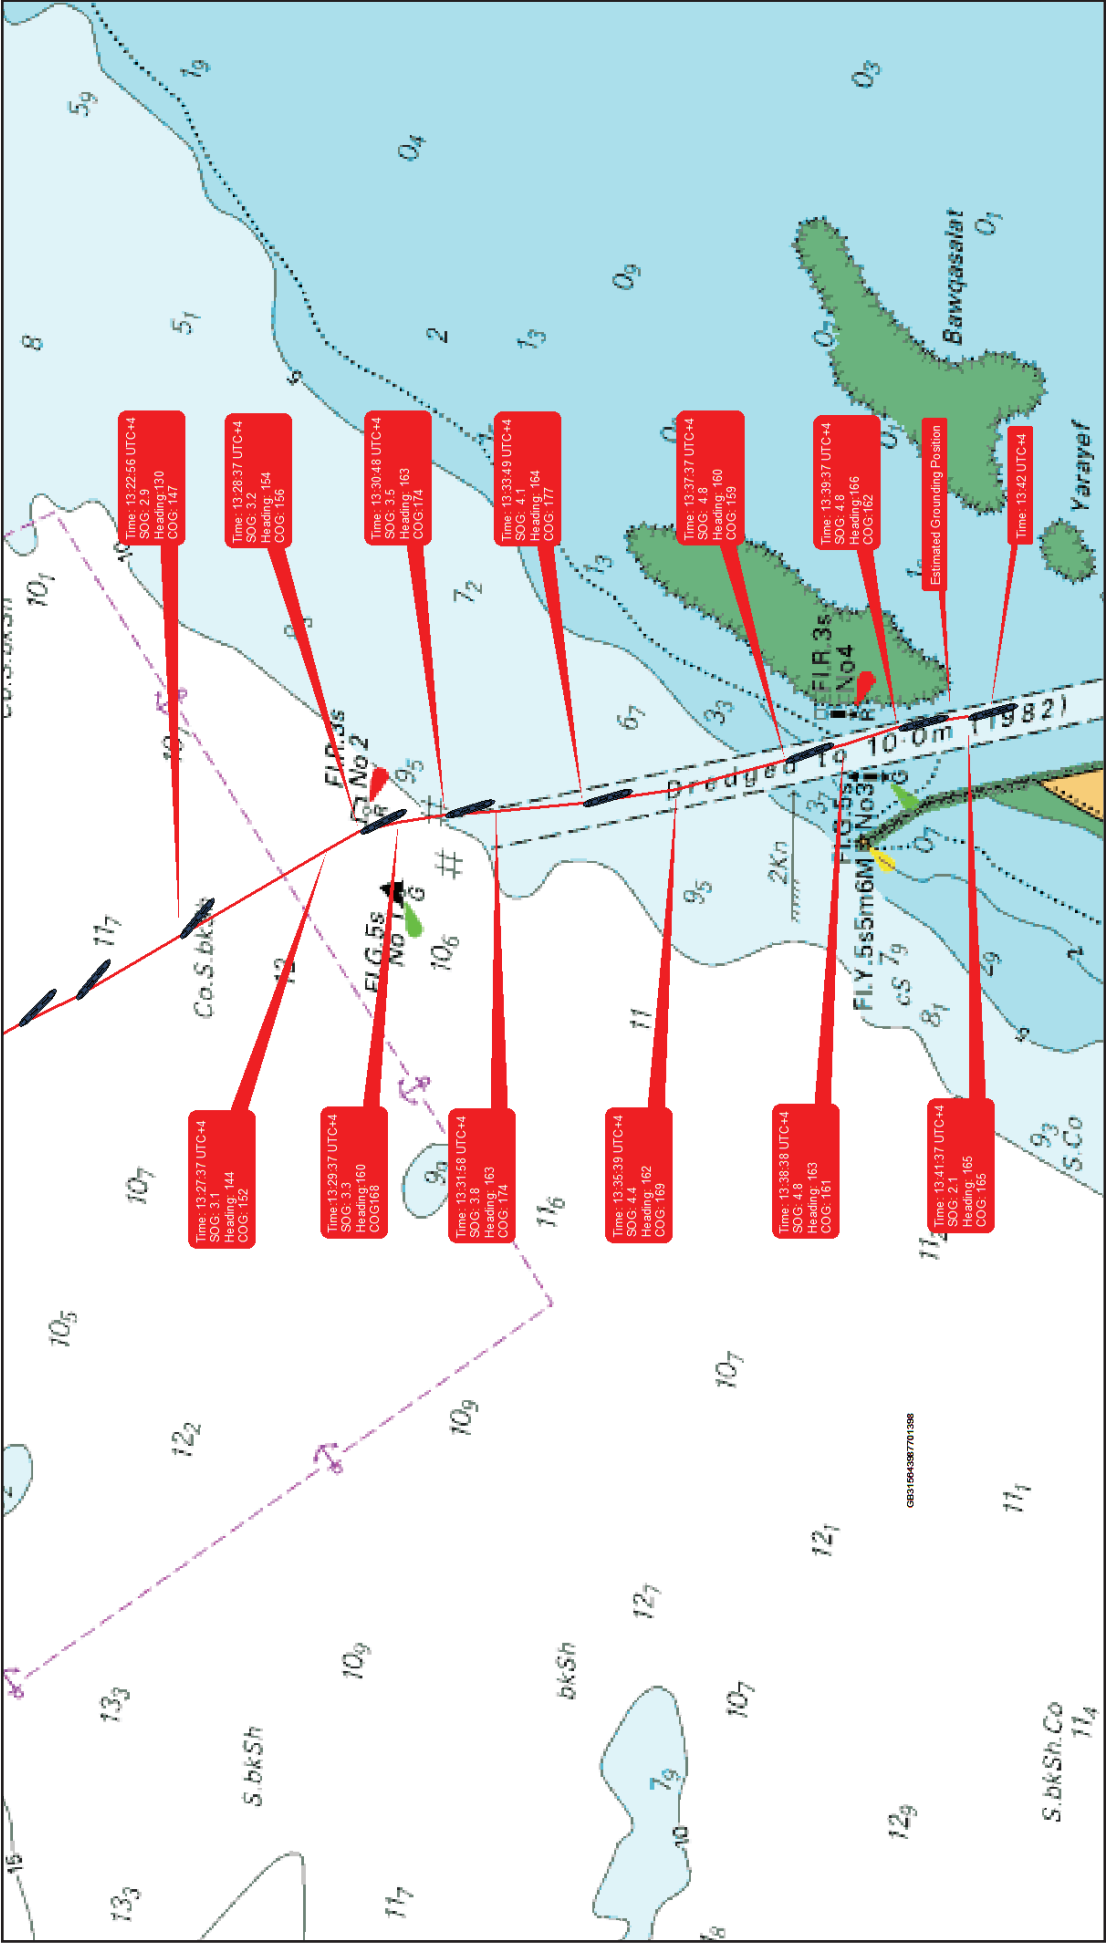
Figure 5: Extract of Admiralty Chart 3405 showing Ocean Prefect's AIS track on 11 June 2017

Figure 5 shows that *Ocean Prefect*'s track after passing the lateral buoys until No.3 and No.4 buoys was largely as intended. The differences between the vessel's heading and its course over the ground indicate that a westerly tidal set at a rate of up to 1kt was again experienced. However, the tidal stream had been anticipated and the headings steered countered the tidal set and *Ocean Prefect* remained within the channel.

However, the tidal set diminished soon after *Ocean Prefect* passed No.4 post at 1339. This was not anticipated or noticed by the master, or the pilots, and the bulk carrier's heading remained at least 1° to the east of the channel's axis of 167° until the vessel encroached onto the eastern limit of the dredged channel and grounded

at about 1342. In view of the vessel's position, it is almost certain that it struck into the side of the dredged channel, but this cannot be confirmed without reference to up to date survey data of the area.

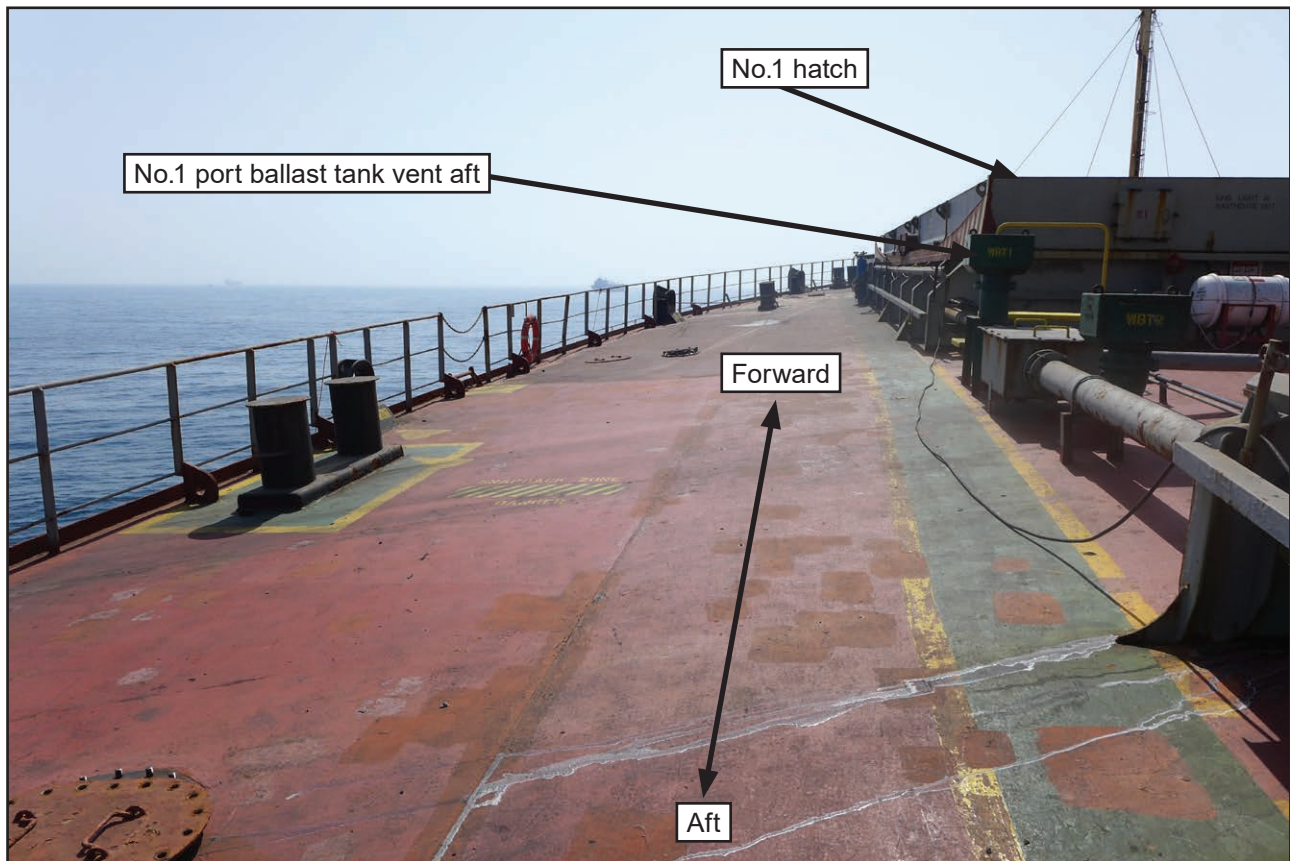
'full ahead' and steered the vessel towards the centre of the channel. At the same time, the chief officer, who was on the port side of the main deck adjacent to the accommodation, investigated an unusual loud noise and found air rushing from the ballast tank vent 'number 1 port aft' (**Figure 6**).

Figure 6: *Ocean Prefect's* main deck, port side

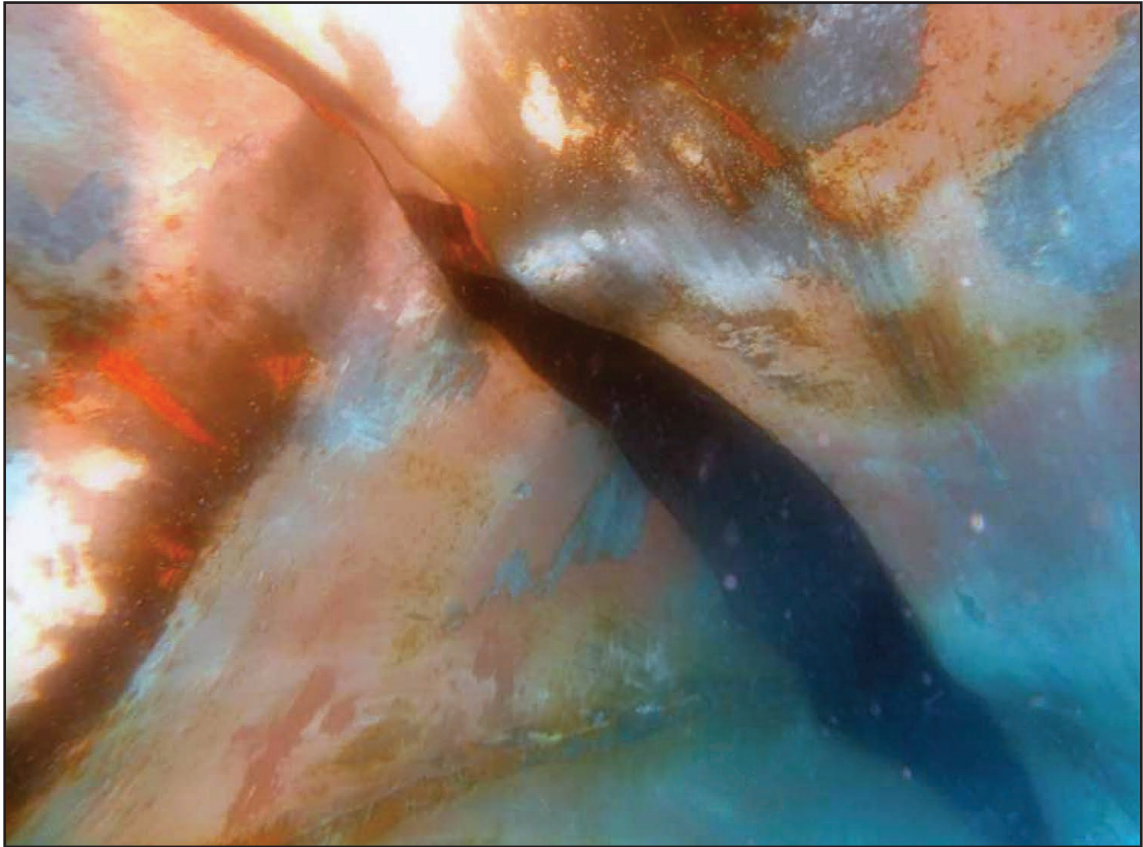
Ocean Prefect's cargo discharge in Umm Al Qaywayn was completed on 16 June 2017. The vessel then sailed and anchored off Dubai, UAE. On 18 June, a dive inspection identified a series of splits, deep indentations and buckling of the shell plating between frames 184 and 109 on the port side. The largest split was 9100mm in length and 200mm wide (**Figures 7 and 8**). Inspection of the starboard side identified only abrasion damage to paintwork. With Lloyd's Register's approval, *Ocean Prefect* proceeded to dry dock in Dubai for repair.

Figure 7: Split in shell plating between frames 169 and 178

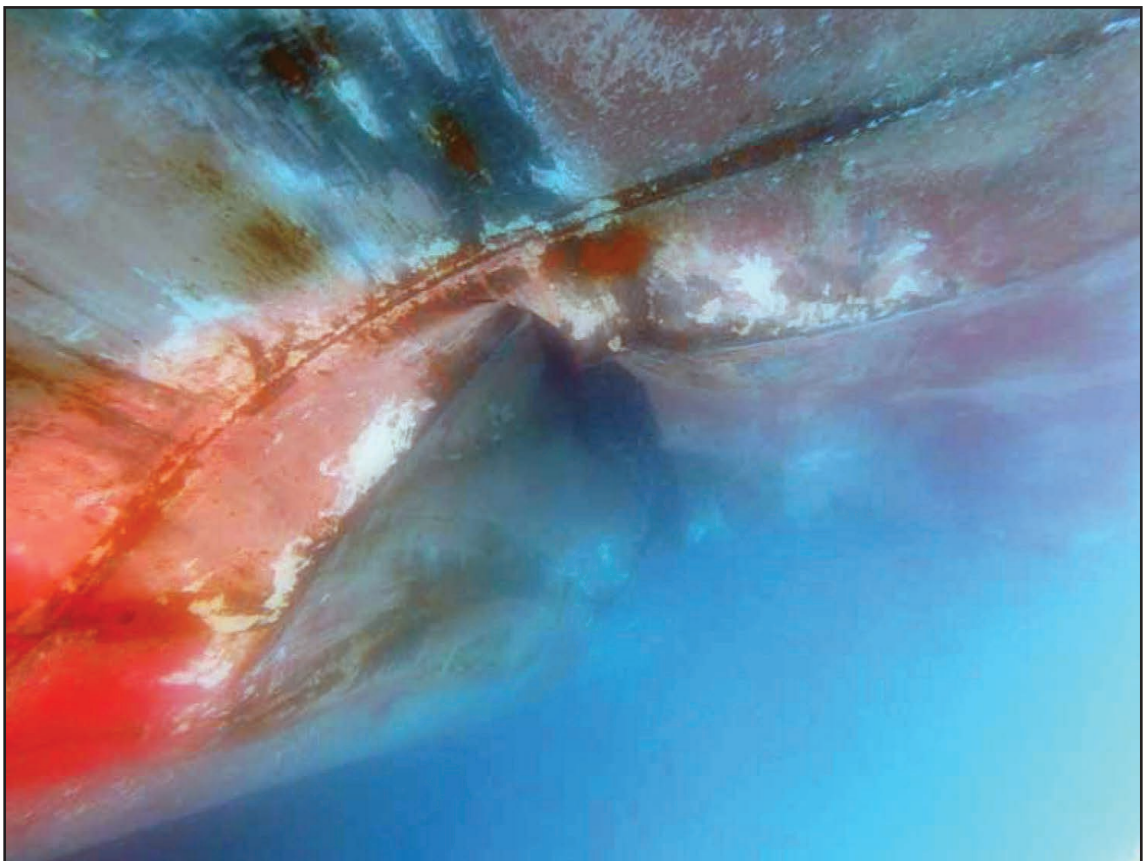
Figure 8: Shell plating deformation between frames 183 and 184

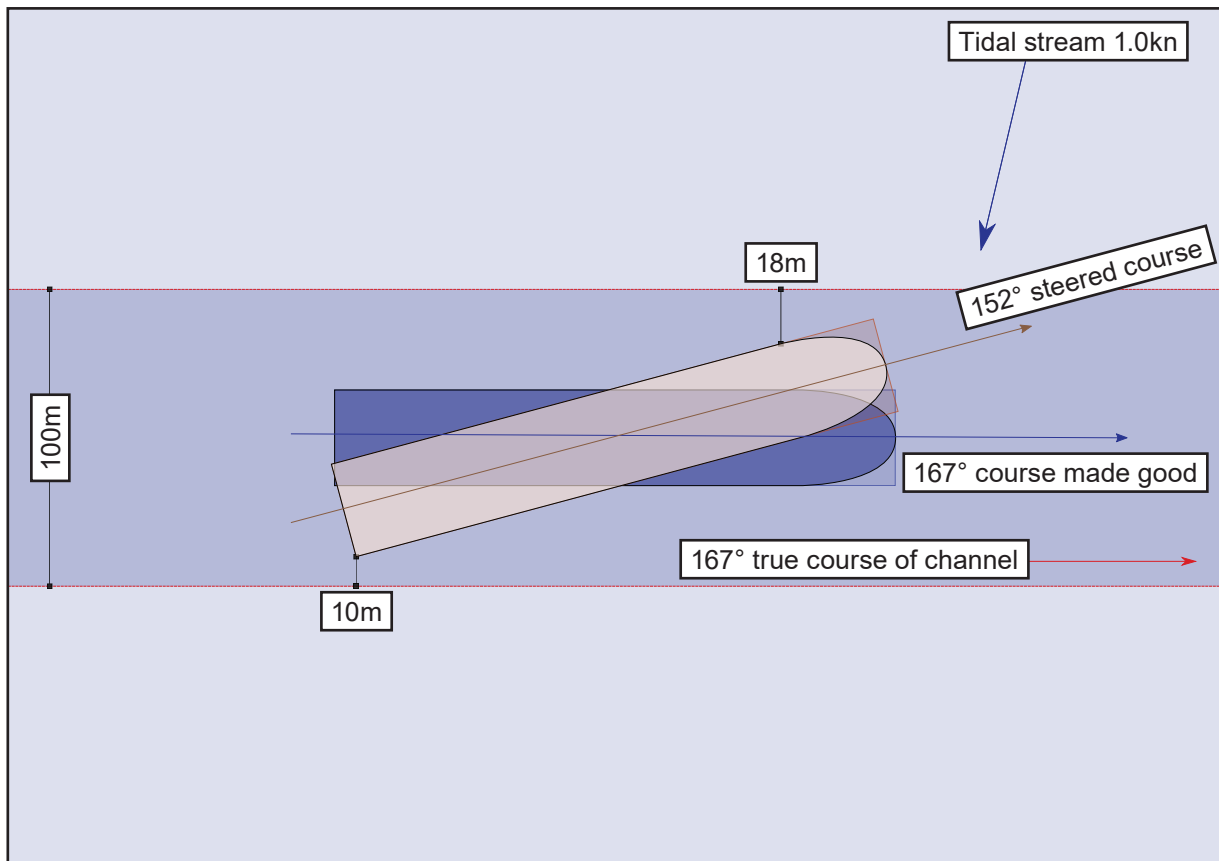
With an axis of 167°/347° between the lateral buoys and No.3 and No.4 posts, the dredged channel runs almost perpendicular to the prevailing tidal stream. Therefore, the tidal stream's effect on transiting vessels is potentially significant. Although this is mitigated to some degree by only allowing the movement of larger vessels around high water, when the tidal stream can usually be expected to be slack, the circumstances of both of *Ocean Prefect's* groundings indicate that this is not always the case. The grounding on 11 June also indicates that the rates and directions of the tidal stream vary at different points along the channel.

The importance of accurate tidal stream data in the approaches to Umm Al Qaywayn is increased by the narrowness and depth of the dredged channel, the length and breadth of larger vessels and their speed restrictions due to squat. As the channel is only 100m wide, the extent to which a vessel can safely deviate from the base axis of $167^{\circ}/347^{\circ}$ is determined by its length and its position relative to the channel's centre. During *Ocean Prefect's* entry on 10 June, at a speed of 4kts, the vessel would have had to steer approximately 152° to counter the 1kt tidal stream and make good a course of 167° . As a result, the vessel's extremities would have been perilously close the channel's limits (**Figure 10**). Consequently, for large, deep draught vessels, slack or near slack water is a prerequisite of safe passage.

Figure 10: Bow and stern clearances of a 189m x 32.3m vessel in a 100m wide channel
