## Contact of Tanker *Atina* with Oil and Gas Production Platform SP-57B

On October 17, 2020, at 0446 local time, the tanker *Atina* with a crew of 21 was attempting to anchor in the Southwest Pass Fairway Anchorage in the Gulf of Mexico, about 21.5 miles from Pilottown, Louisiana, when it struck the manned oil and gas production platform SP-57B.<sup>1</sup> The platform's four crewmembers and one technician evacuated to a nearby platform by helicopter after activating the emergency shutdown device to shut in wells to the SP-57B platform. No pollution or injuries were reported. Estimated damages to the platform (\$72.3 million) and vessel (\$598,400) totaled \$72.9 million.<sup>2</sup>

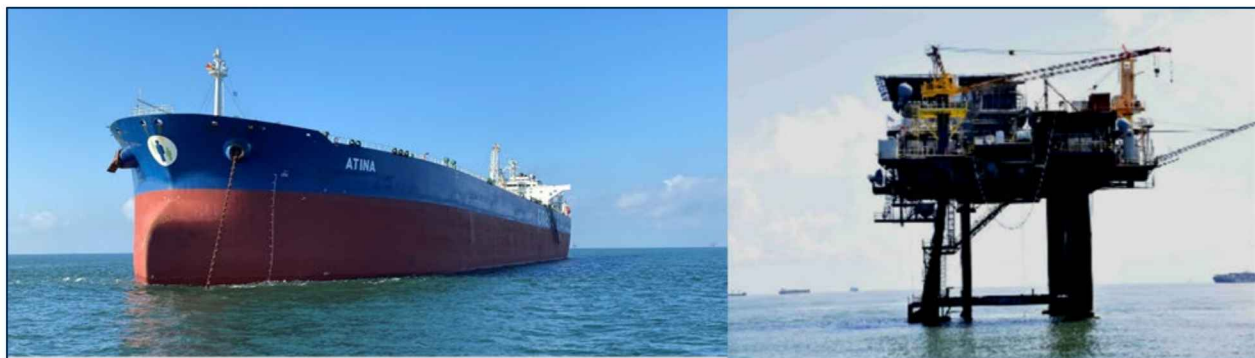
**Figure 1.** *Atina* postaccident (left); SP-57B preaccident (right). (Sources: US Coast Guard, Cox Operating)

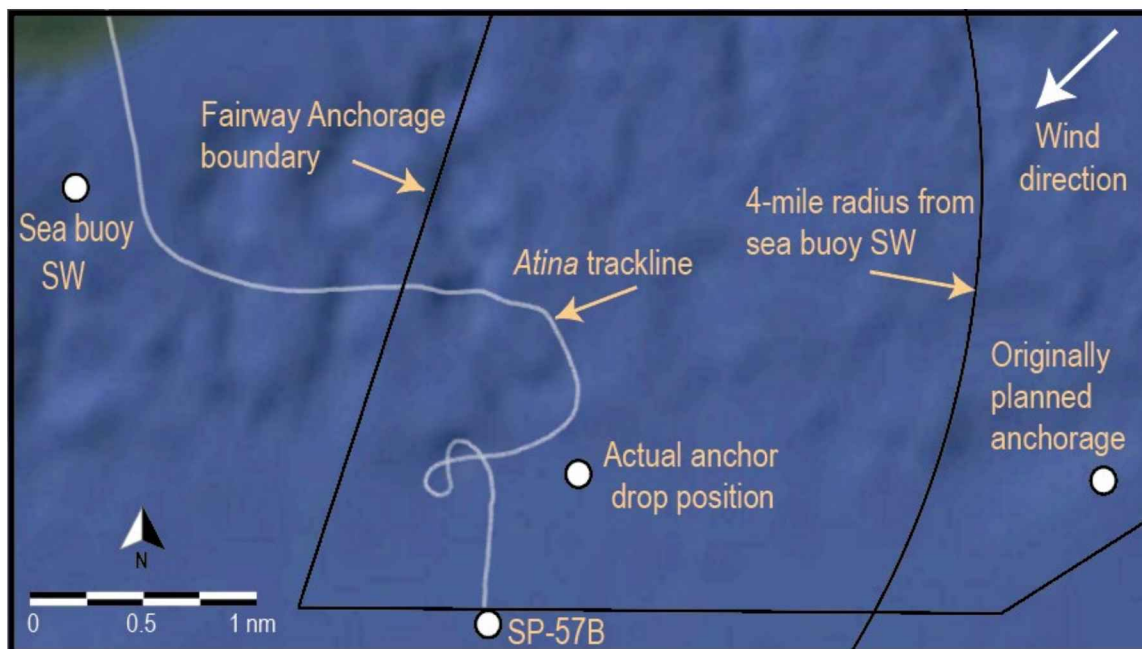
According to *Atina's* passage plan, dated October 16, the tanker's intended anchorage in the Southwest Pass Fairway Anchorage area was about 3.2 miles northeast of SP-57B and about 5.5 miles southeast of the sea buoy. However, the accident master told investigators that he didn't want to spend a lot of time finding a place to anchor in the middle of the night on a vessel he wasn't familiar with. He also told investigators that he wanted to anchor the tanker soon after the Associated Branch pilot's departure because he was tired from having no sleep for over 50 hours while traveling to join the ship. He checked the electronic chart display and information system (ECDIS) and planned to drop the anchor in the Fairway Anchorage area, in what he deemed was a safe place, about "7 cables" (equivalent to 0.7 miles) from the platform SP-57B.

**Figure 3.** *Atina*'s trackline, taken from VDR data overlaid on a Google Earth image, showing the tanker's position relative to sea buoy SW and platform SP-57B within the Fairway Anchorage boundaries. The image also shows *Atina*'s originally planned anchorage location, trackline, actual anchor drop position, and the 4-mile radius from sea buoy SW.

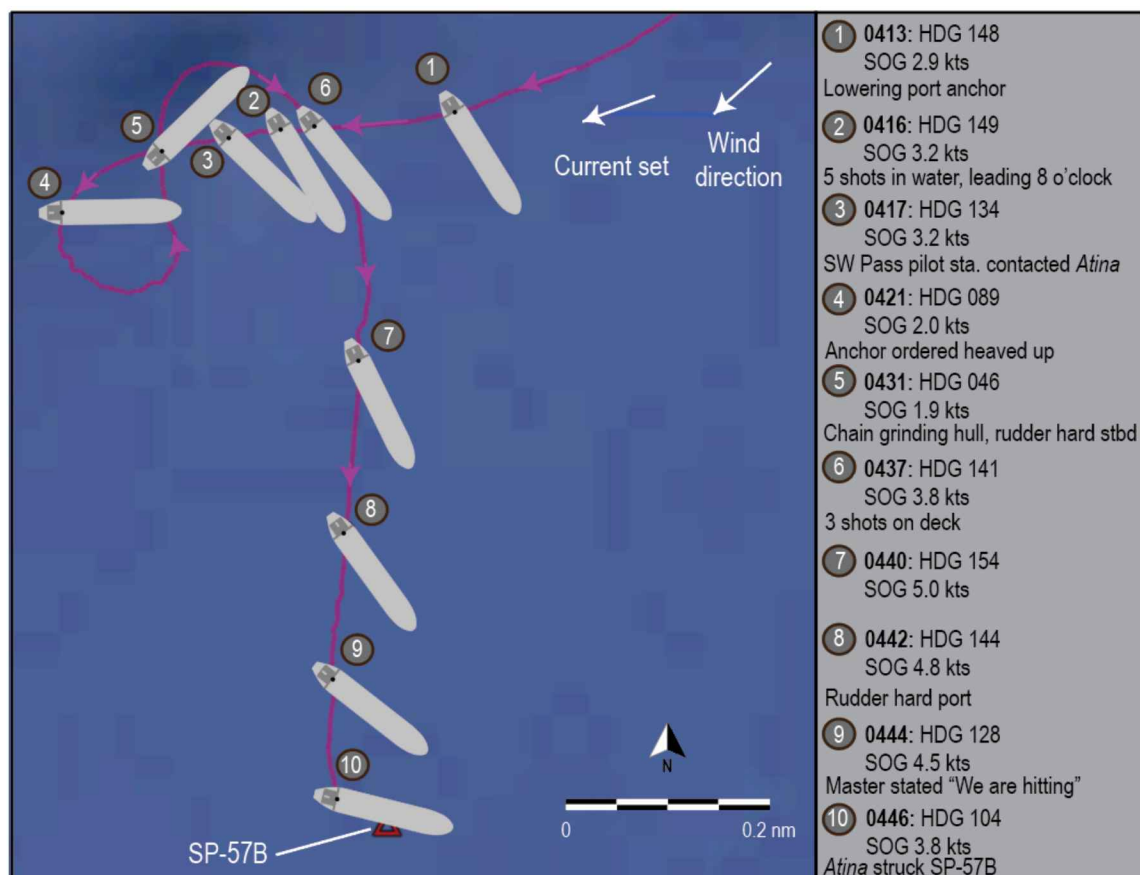
The master then asked the second mate for the distance from the other vessel, and the mate replied, "One mile bearing 175°." At 0440, after first remarking that it looked like the ship was "closing in," the master asked the second mate what the ship was doing, to which the second mate replied, "She is speeding with 5.3 knots at this moment." At the same time, *Atina* was making a speed over ground of 5 knots. About 0441 the master asked the second mate for the name of the ship, and the second mate replied, "*Leader*, sir, at starboard." The master replied, "This is not a ship, it is a platform." About 0442, parametric data obtained from the tanker's VDR showed the rudder went from midship to 32° to port. At 0444, the master stated, "We are hitting," and, according to parametric data from *Atina*'s VDR, at 0446 the starboard side of *Atina* struck the northern side of SP-57B at 3.8 knots.

**Figure 4.** *Atina*'s trackline, taken from VDR data overlaid on a Google Earth image, showing the ship's heading and speed over ground before the accident.

The weather conditions included winds of about 25 knots out of the northeast. The Associated Branch pilot had informed the master of the strong westerly set, and the radar indicated a set and drift of about 247° at 1.5 knots. However, the master did not adequately account for the westerly setting current and northeasterly wind that pushed his vessel toward the platform. Likely preoccupied with bringing the anchor in clear from the hull, the master ordered hard starboard rudder while the platform was on the *Atina*'s starboard quarter and with the wind coming from dead ahead. By doing so, he ended up pivoting *Atina* toward SP-57B and putting the wind and current on the *Atina*'s port side, which caused the vessel to set toward the platform. As the platform's relative position to *Atina* shifted from the tanker's starboard quarter to the starboard bow and the ship pivoted about the anchor chain, the combination of set and *Atina* moving ahead brought the tanker in contact with the platform as the amount of chain in the water lessened and the ship gathered speed.

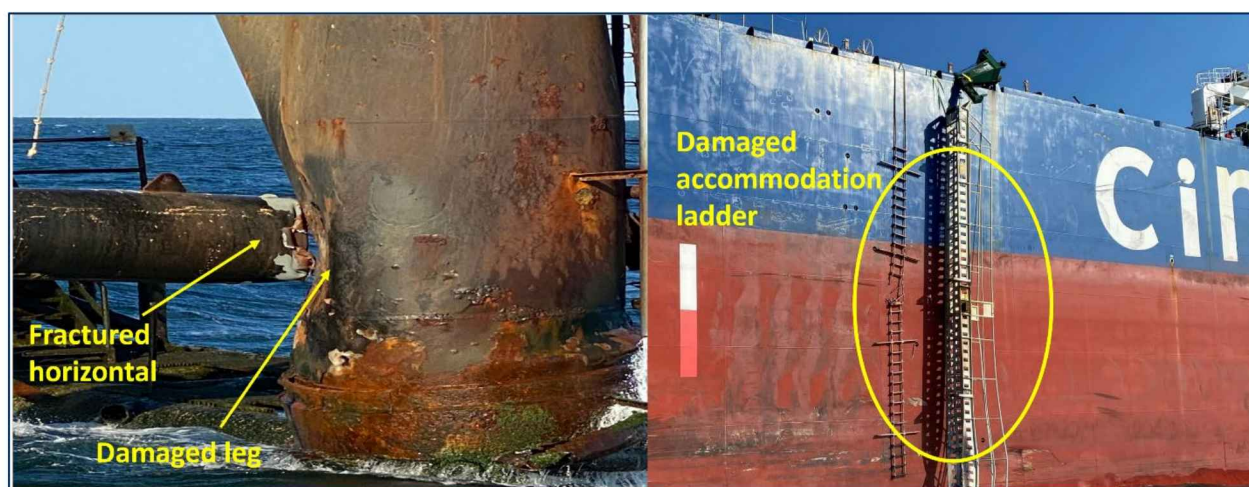
As a result of the strike, *Atina* sustained \$598,400 in damages to its starboard accommodation ladder and indentations to hull plating in ballast tanks 3-starboard and 5-starboard. SP-57B's owner/operator reported that SP-57B sustained a fractured and bulged leg as well as severed, buckled, and crushed structural members above and below the waterline. The total cost of damages to the platform was estimated at \$72.9 million.

**Figure 5.** Damage to SP-57B (left) and *Atina* (right). (Source: Coast Guard)

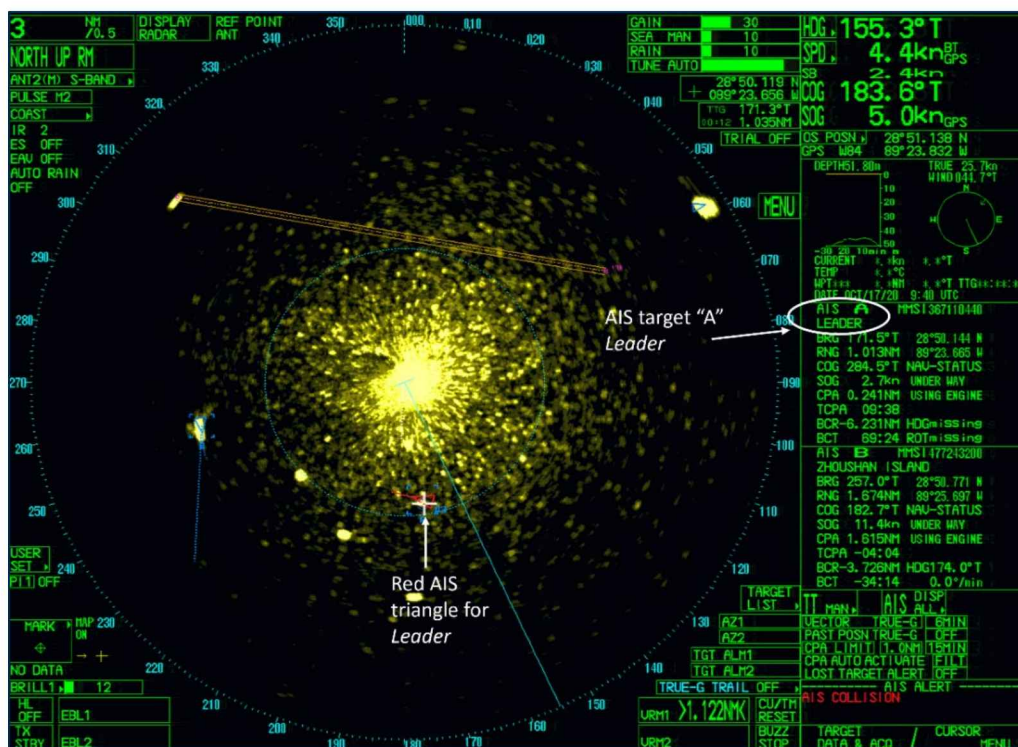
*Atina*’s VDR information included data from the S-band and X-band radars. At the time of the accident, the S-band radar was set to a 3-mile range. The S-band radar screen showed the offshore supply vessel *Leader* as an automatic identification system (AIS) target. The alarm “AIS COLLISION” was visible in red text under “AIS ALERT” on the S-band radar screen. The X-band radar was set to a 1.5-mile range and did not show any alarms or AIS information. The second mate told investigators that an alarm was activated on the radar he was referencing in the time leading up to the accident.

**Figure 6.** Screen capture of *Atina*'s S-band radar at 0441. The range is set to 3 miles and the offshore supply vessel *Leader* is listed as an AIS target. Also visible in the bottom right corner is the text "AIS COLLISION" in the "AIS ALERT" section.

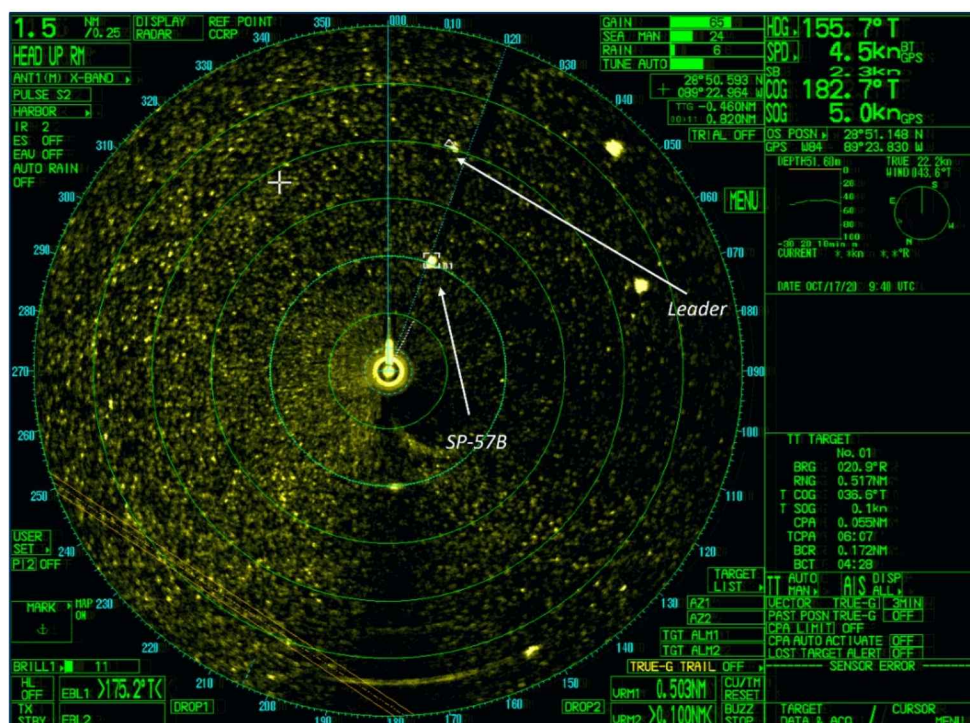
**Figure 7.** Screen capture of *Atina*'s X-band radar at 0441. The range is set to 1.5 miles.

After *Atina* had already begun anchoring, the Southwest Pass pilot station asked the vessel to move to a location greater than 4 miles from sea buoy SW, since *Atina* was within 4 miles of the sea buoy (the passage plan anchorage was outside the radius). As the crew was heaving the anchor to comply with this request, the bridge team lost track of the platform's location. Based on the VDR audio, it appears that the master believed the platform was another vessel. When the master asked what the vessel at 6 cables was doing (platform SP-57B was at that approximate distance), the second mate gave the master distances and information for the offshore supply vessel *Leader*, which was located 1.5 miles away from the tanker, 0.9 miles beyond SP-57B. The S-band radar was the only radar that included vessel names and the only radar showing an alarm. Because the second mate informed investigators that an alarm was activated on the radar he was using, it is likely that the second mate was looking at the S-band radar. The S-band radar was set at a scale of 3 miles, making platform SP-57B difficult to see because it was lost in radar clutter close to the *Atina*. The master was likely looking at the X-band radar, on which the scale was set to 1.5 miles, making the SP-57B easily visible at 0.5 miles.
