**Australian Government**  
**Australian Transport Safety Bureau**

# Collision involving the bulk carrier Goliath and tugs York Cove and Campbell Cove, Devonport, Tasmania, on 28 January 2022

<b>Investigation number</b>	<b>Report release date</b>	<b>Report status</b>
MO-2022-002	22/03/2023	Final
<b>Investigation level</b>	<b>Investigation type</b>	
Defined	Occurrence Investigation

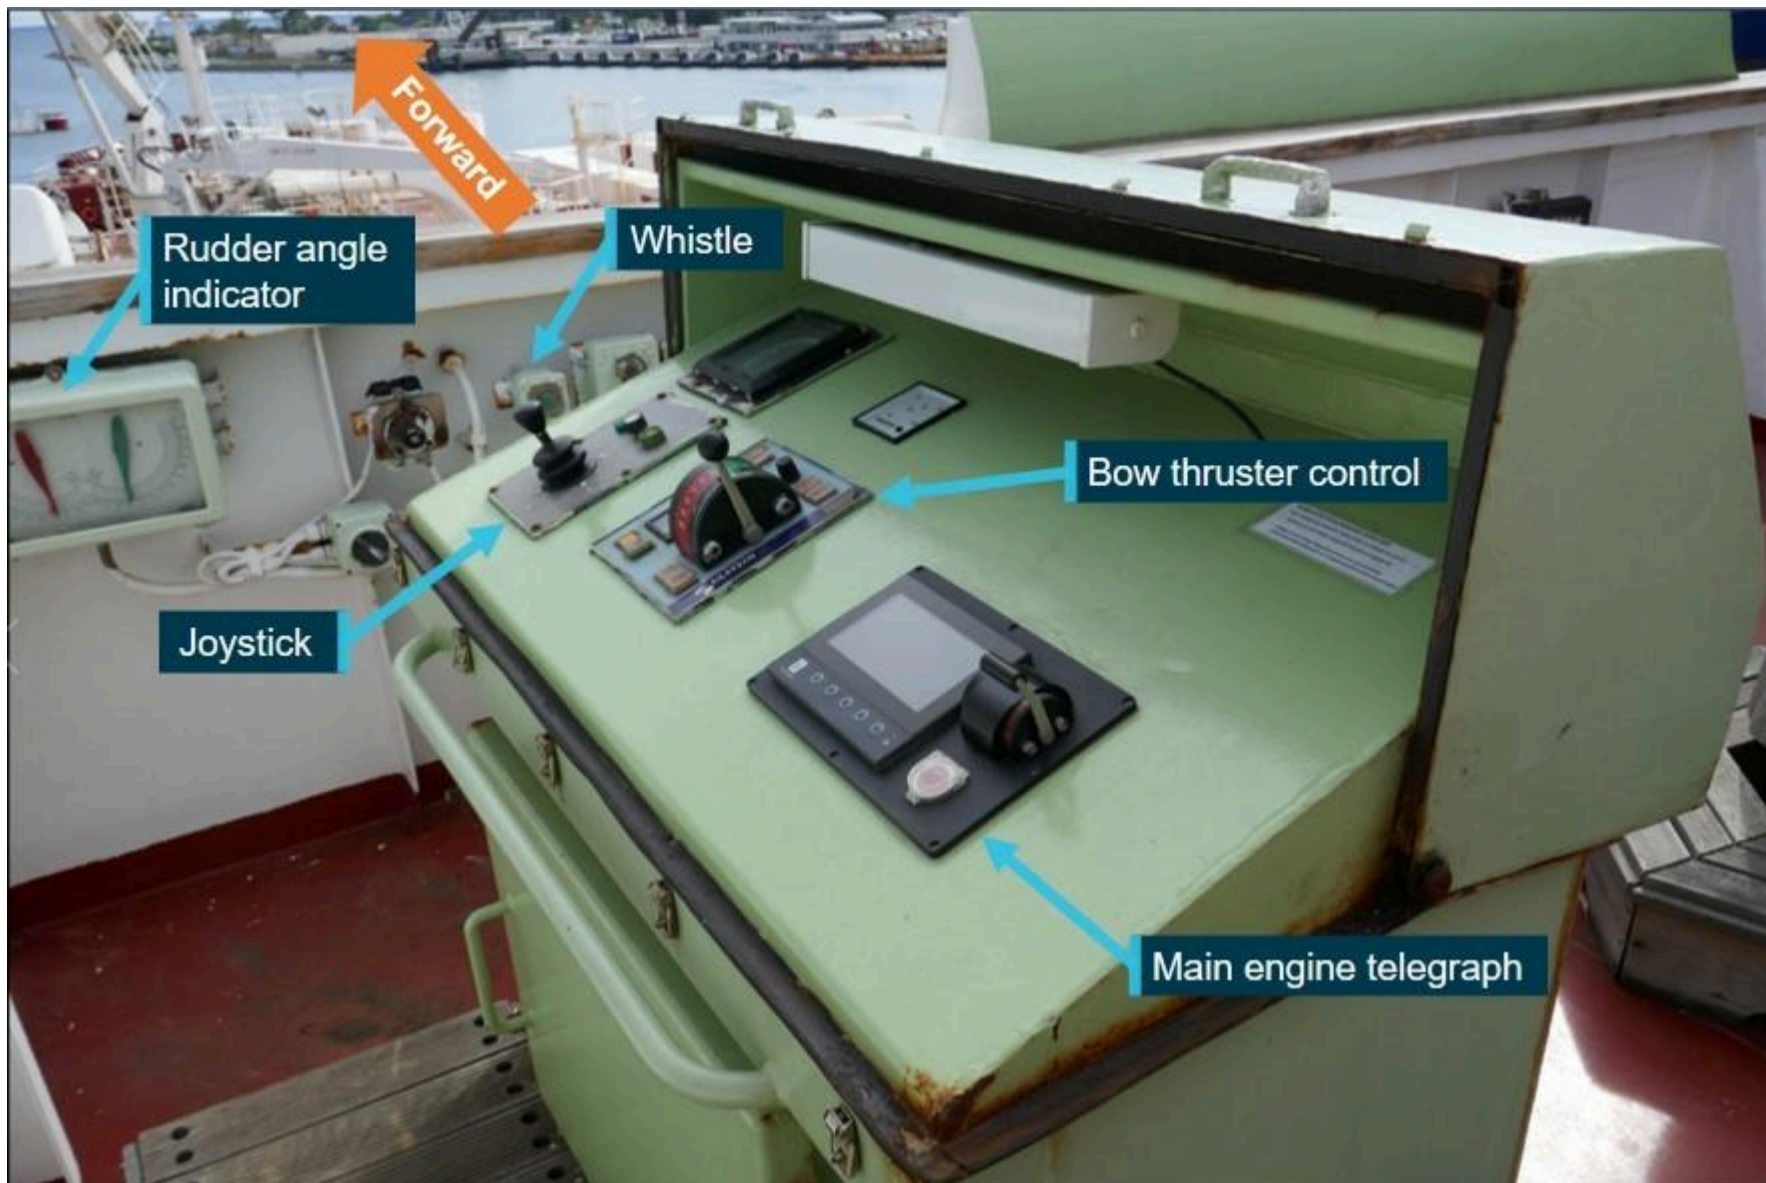
**Figure 5: *Goliath's* port bridge wing conning station (looking forward)**

Once the second mate confirmed that the wing console was ready, the master walked out and took the con at the port bridge wing conning station (Figure 5). The chief mate, who had walked to the bridge wing door and observed the second mate taking control of the propulsion and steering at the wing console, then left the bridge and went down to the mess room.

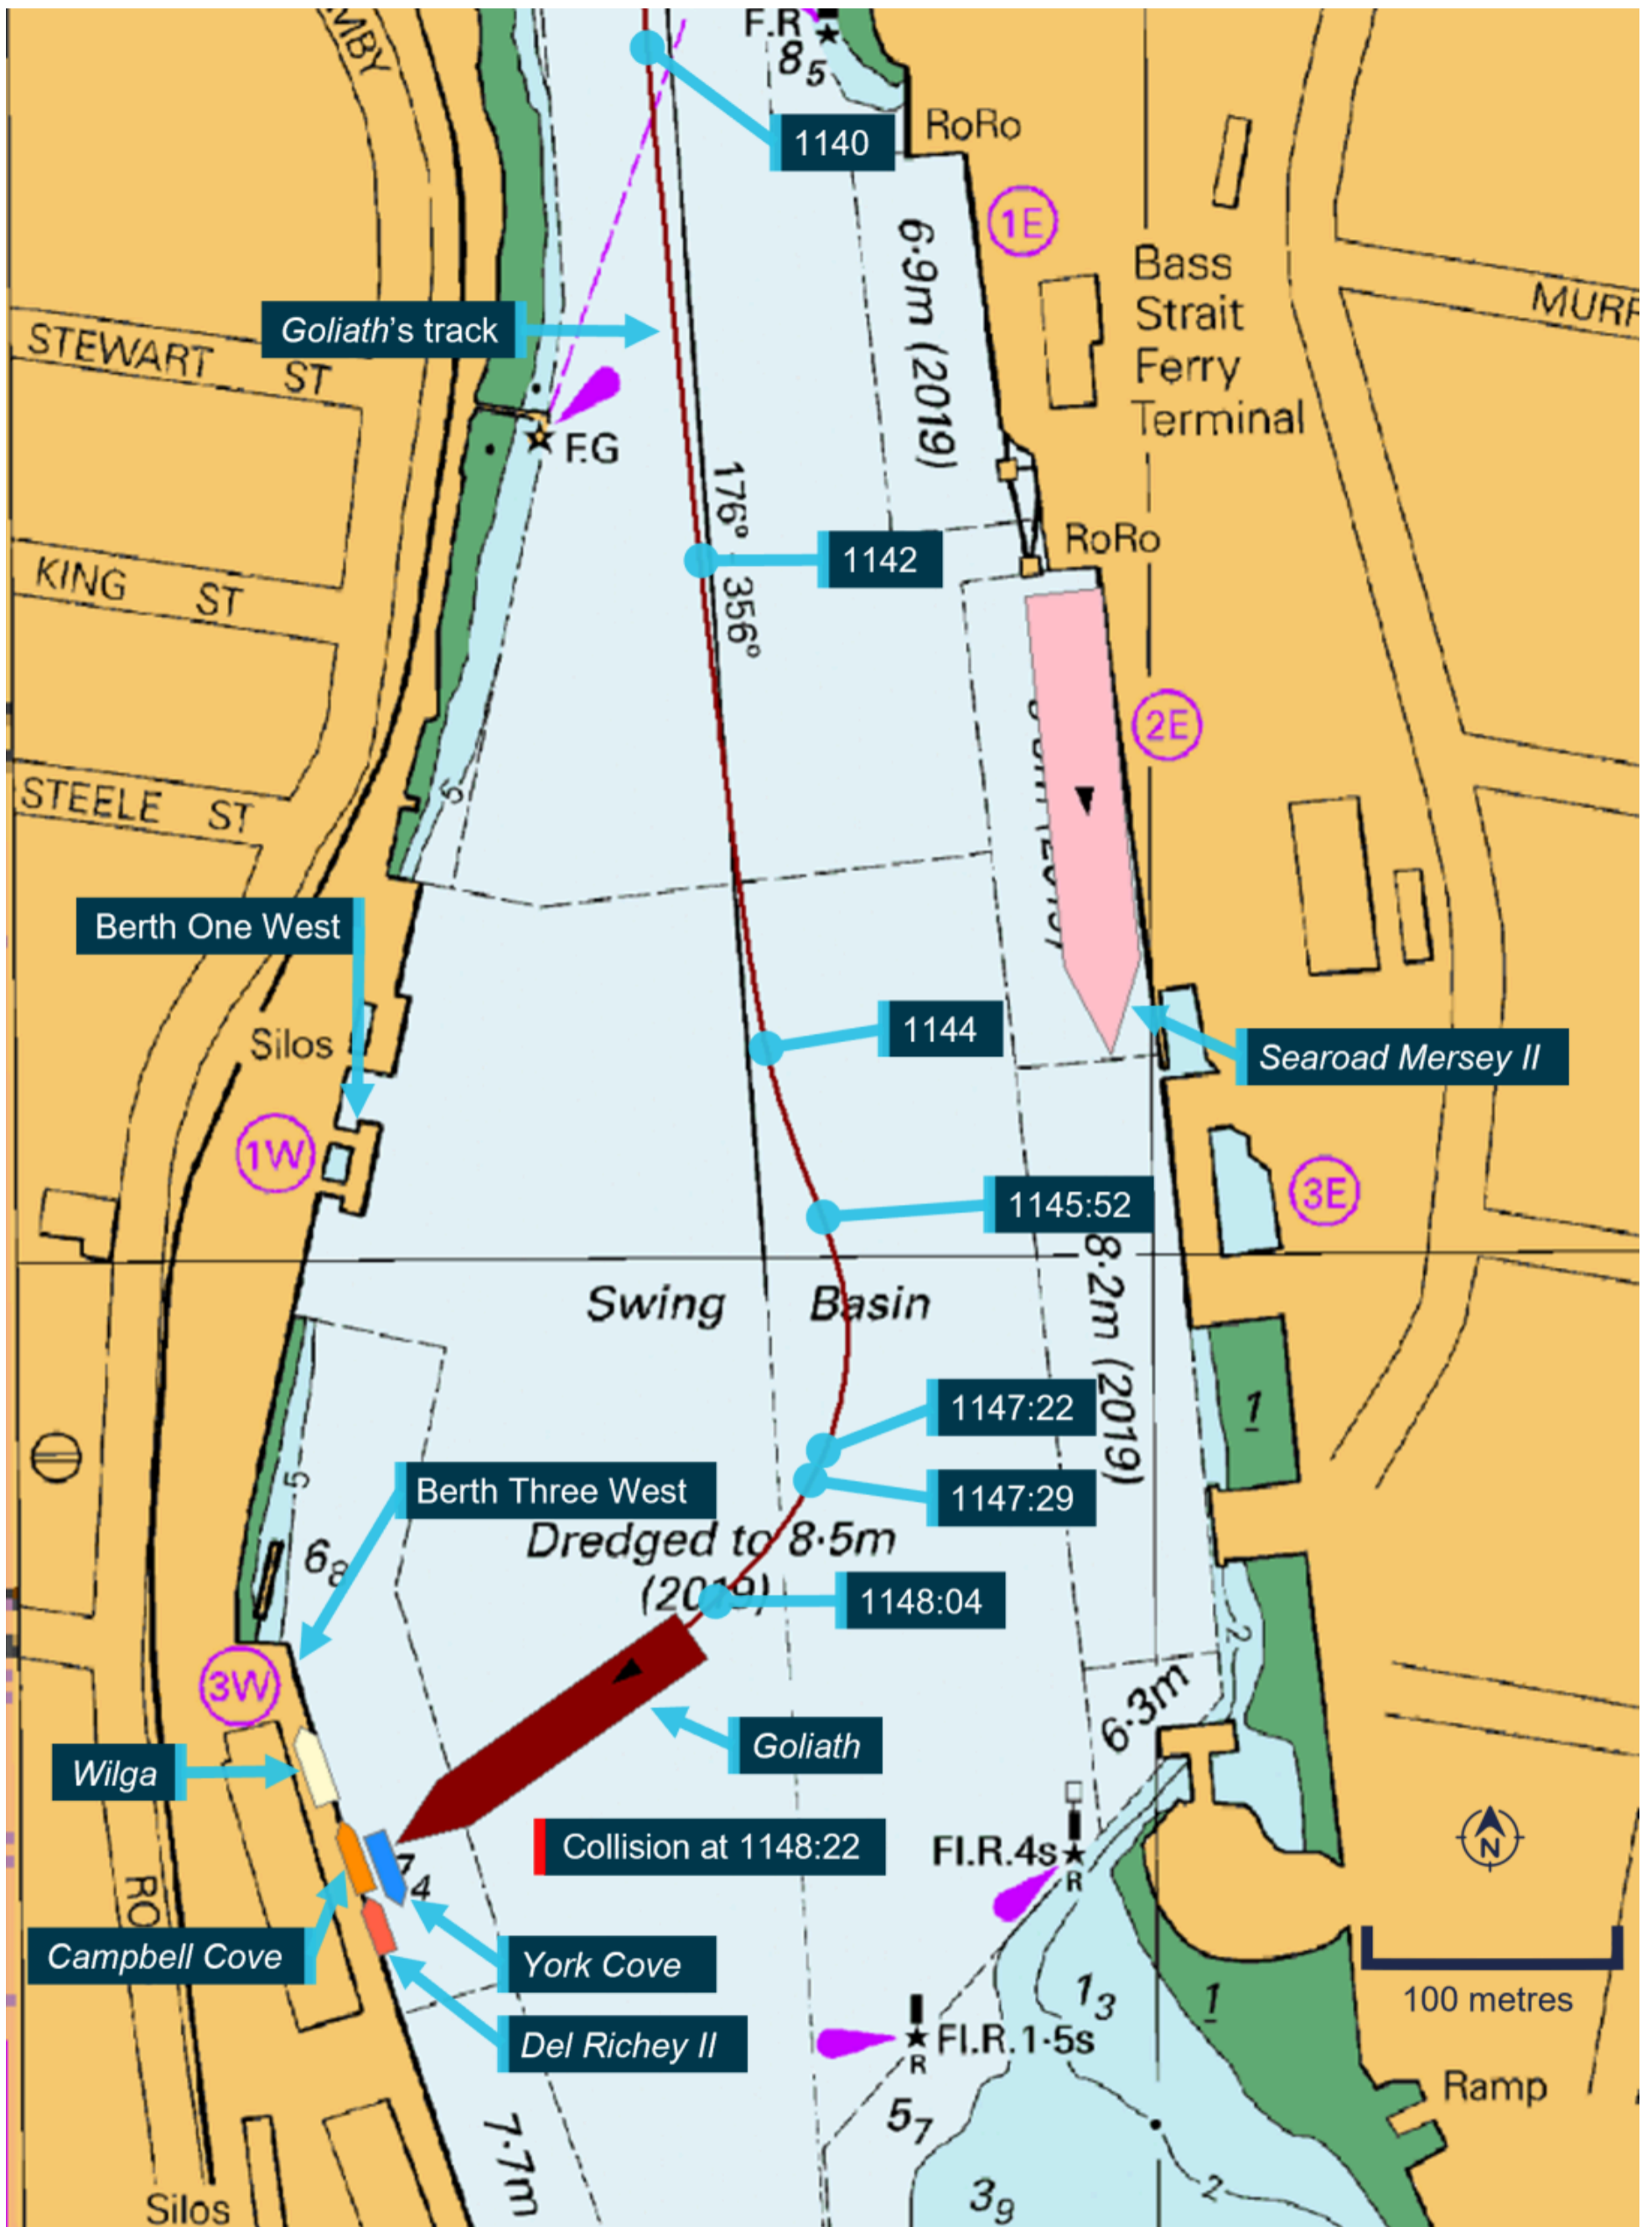
**Figure 6: Section of chart Aus 164 showing *Goliath's* track and sequence of collision**

As the manoeuvre progressed, the master felt that the ship was not swinging as expected and was closing with 2 tugs, which were moored at berth number Three West ahead. In an effort to arrest the ship's headway, the master set the VecTwin joystick to the 'astern' setting<sup>[10]</sup> and, at 1147:22, placed the main engine at 'half ahead'. A few seconds later, at 1147:29, the master used 'full ahead', but the ship's headway continued to increase, with the speed now about 2.9 knots. Meanwhile, the bosun had begun reporting rapidly decreasing clearances to the tugs ahead. The bridge engine telegraph data logger shows that at 1147:41, the telegraph was placed at 'half ahead' before quickly being returned to 'full ahead'. At 1148:04, the master placed the telegraph at 'navigation ahead' (that is, the maximum ahead engine telegraph setting). The ship's speed had increased to 4 knots.

With the ship's speed still increasing, the master checked the rudder angle indicator located in front of the port wing console and then observed that both rudders were still amidships and not at the angles corresponding to the VecTwin joystick setting as expected. The master called out to the second mate that the steering was not in VecTwin steering mode and immediately brought the engine telegraph to 'slow ahead' and then to 'stop'.

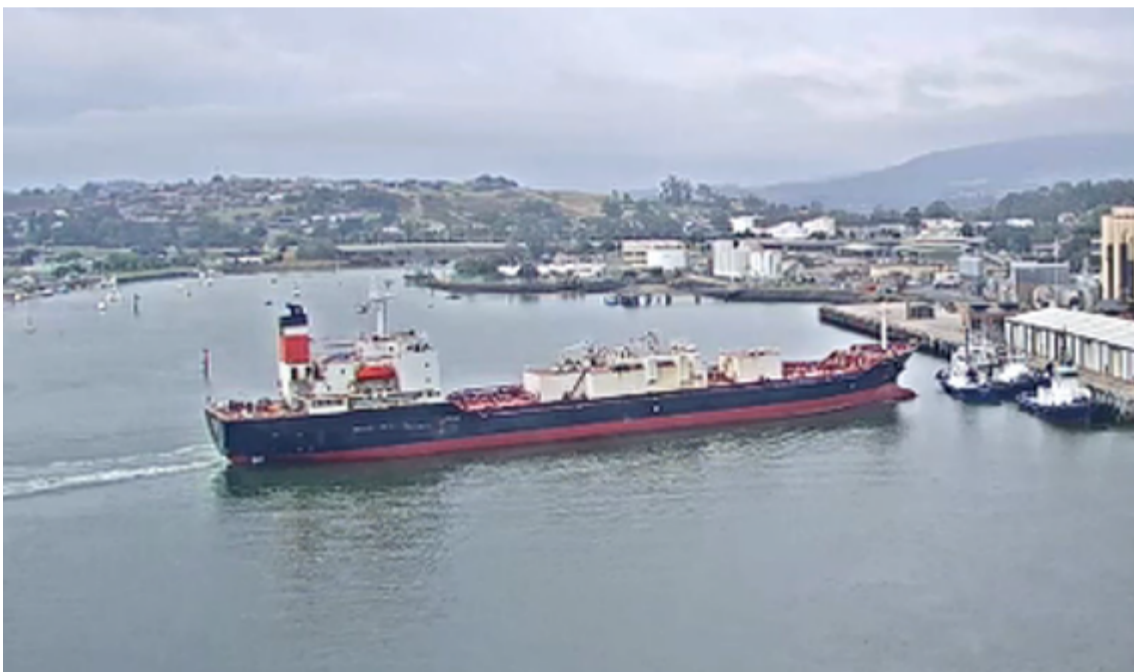
**Figure 7: *Goliath*, immediately before the collision with the tugs**

At about the same time (1148:22), *Goliath* collided with the two tugs ahead. (Figure 7). The ship's speed was 4.7 knots as it struck the port midships area of the tug *York Cove*, which was moored outboard, and alongside, of the tug *Campbell Cove*.<sup>[11]</sup> Both the tugs were severely damaged and began taking on water almost immediately. The tug *Wilga* and the fishing vessel *Del Richey II*, berthed to the north and south of the two damaged tugs respectively, were not impacted.

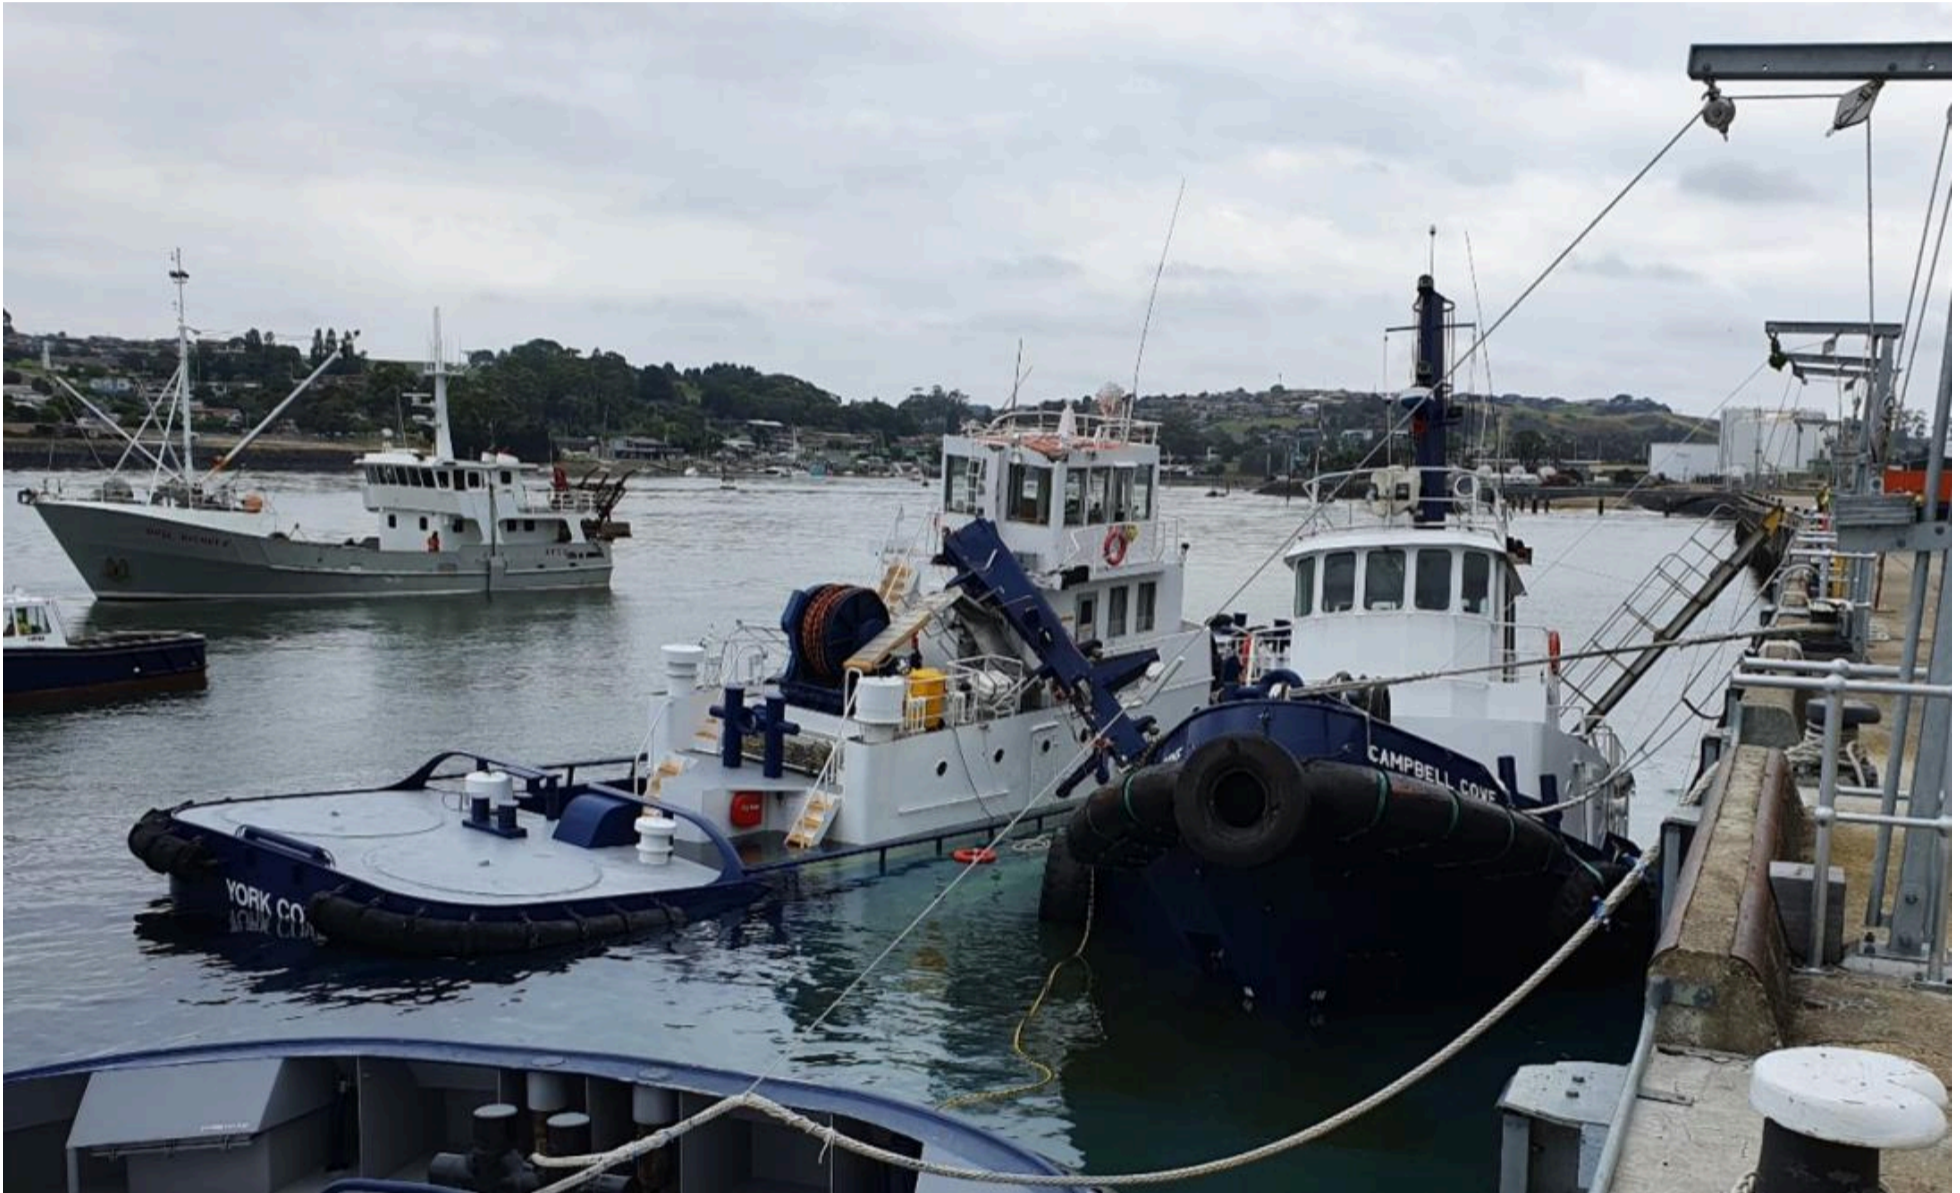
**Figure 8: York Cove and Campbell Cove about 20 minutes after the collision**

By about 1220, both damaged tugs had developed a list to starboard as they took on more water and oil began to escape (Figure 8). By this time, the fishing vessel *Del Richey II* had cast off from its berth and taken up station nearby to assist. The tug *Wilga* remained alongside the berth.

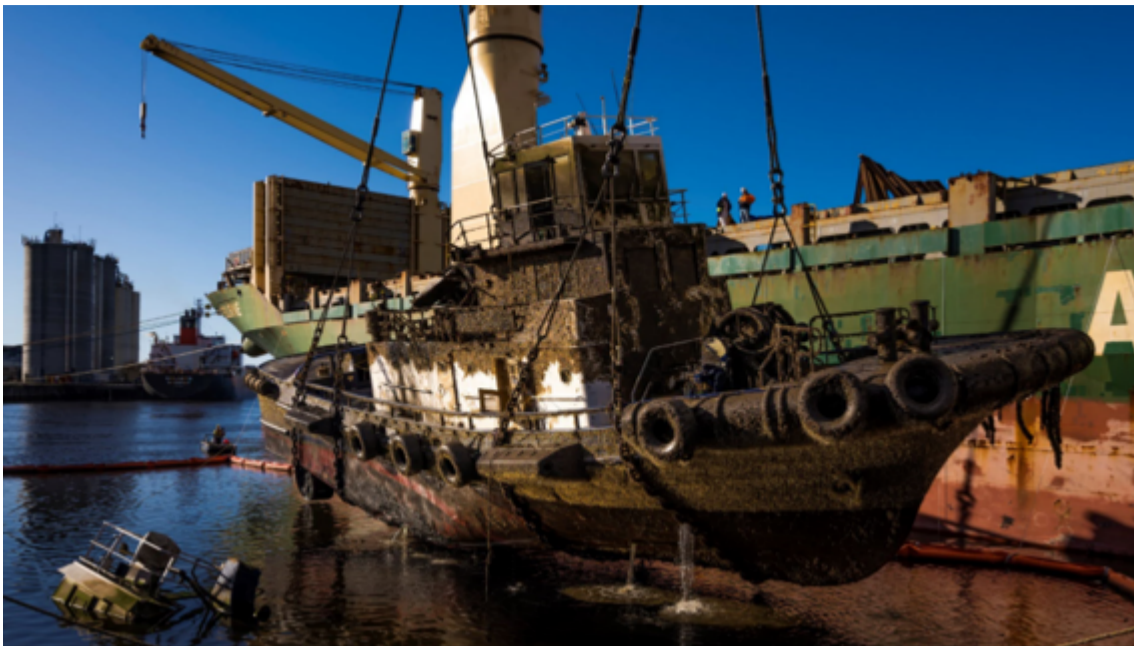
**Figure 10: York Cove being recovered**

Both *York Cove* and *Campbell Cove* were declared constructive total losses. On 11 March 2022, United Salvage were awarded the tender for removal of the wrecks of the sunken tugs. In July 2022, the heavy-lift ship *AAL Melbourne* was engaged to lift and remove the tugs’ wrecks. The ship arrived in Devonport on 7 August and recovered *York Cove*’s wreck (Figure 10). *Campbell Cove*’s wreck was also recovered by 12 August. During the recovery operation, an unknown quantity of oil escaped the containment area although EPA surveys of the shoreline and water did not detect any affected wildlife. *AAL Melbourne* departed Devonport on 16 August for Brisbane, Queensland where the tugs were to be scrapped (recycled).

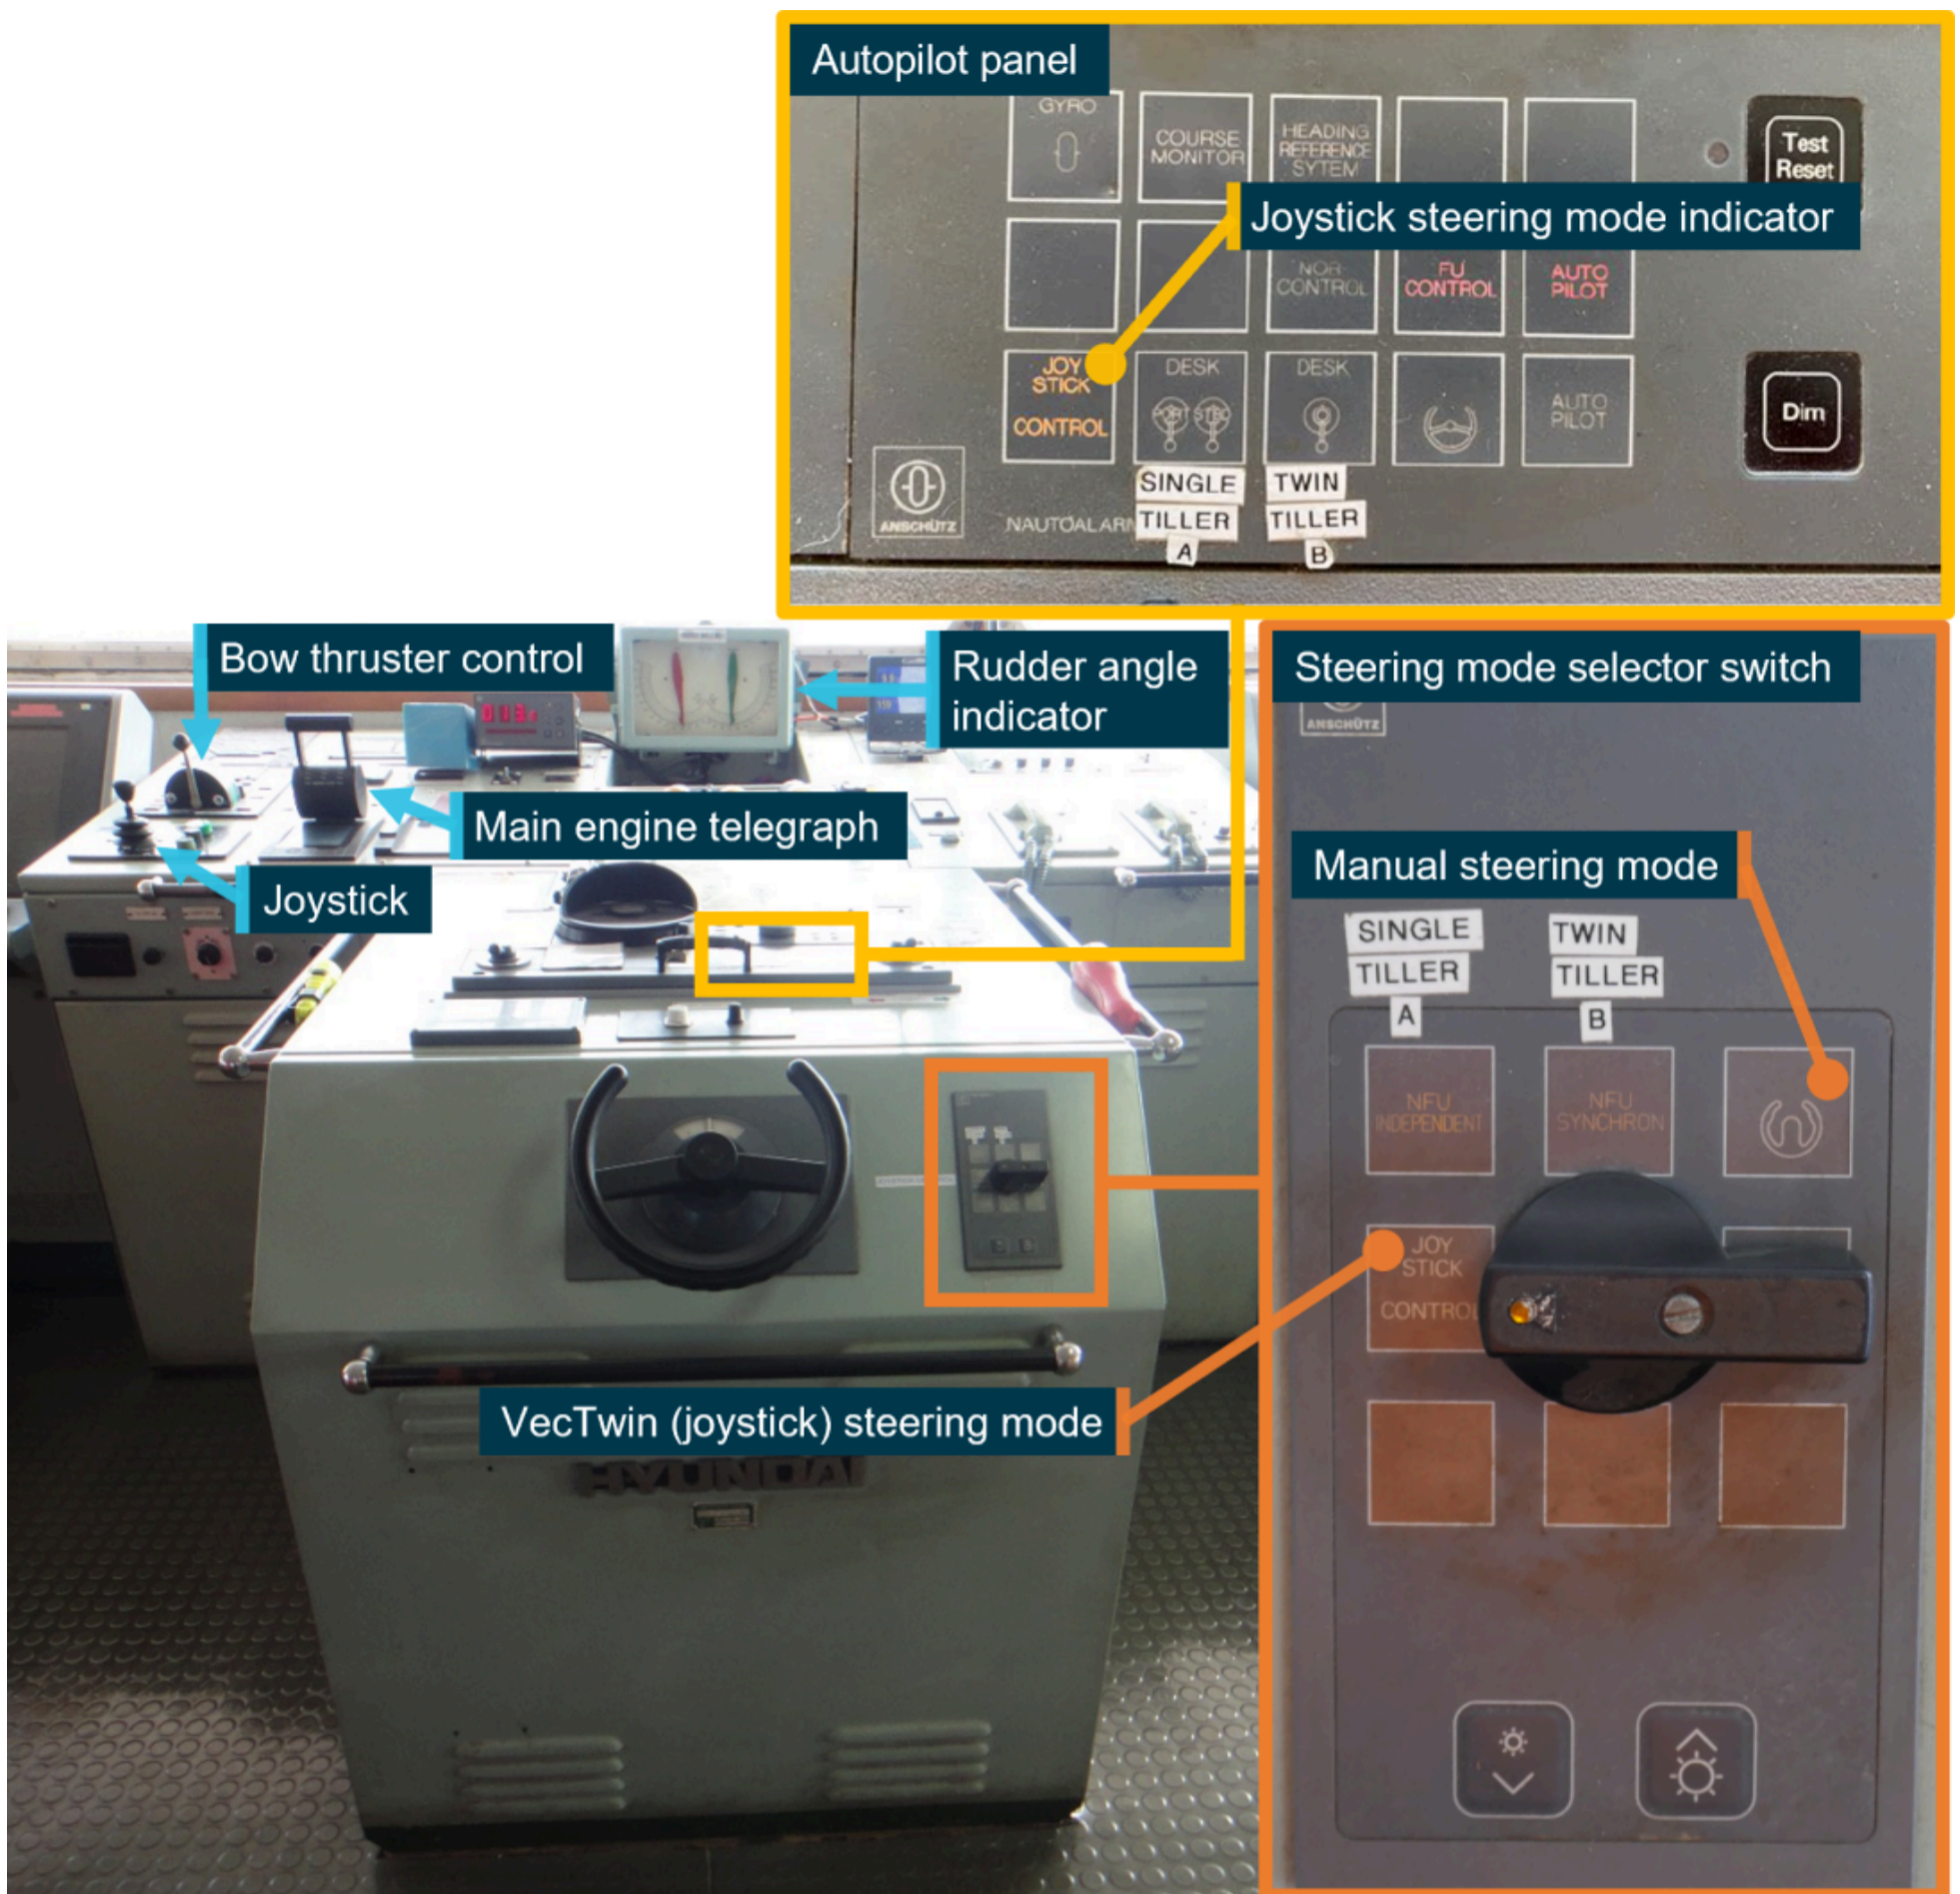
**Figure 11: *Goliath's* wheelhouse, steering console, and steering mode selector switch**

On board *Goliath*, the second mate had run into the wheelhouse, checked the steering mode selector switch on the steering console and realised that it was still in manual steering mode. The second mate immediately switched it over to VecTwin (joystick) steering mode while the master placed the engine at 'half astern' followed by 'full astern' and, by 1148:31, at 'emergency astern'.
