Tanker Master’s Fatigue Cited in \$73 Million Marine Accident

A tanker operating company’s decision to change masters without a handover period led to a \$72.9 million marine accident off the coast of Louisiana, according to a National Transportation Safety Board Marine Accident Brief issued Tuesday.

[Marine Accident Brief 21/24](#) details the NTSB’s [investigation](#) of the October 17, 2020 accident, in which the tanker Atina struck the oil and gas production platform SP-57B near Pilottown, Louisiana.

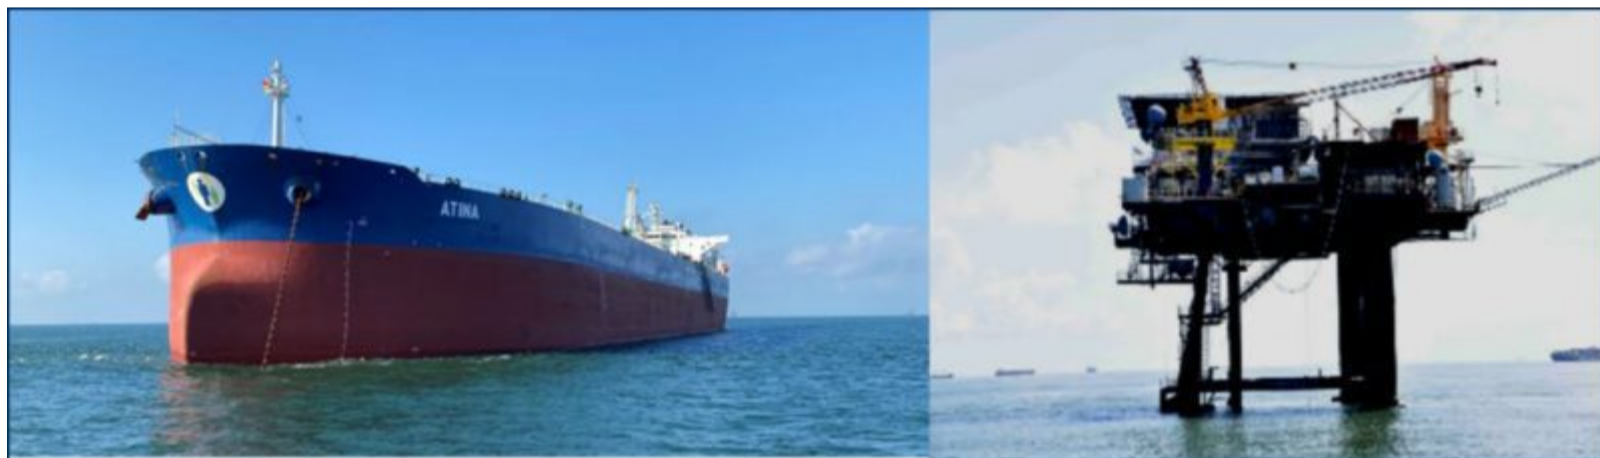
The Atina is pictured postaccident on the left and the SP-57B platform is pictured preaccident on the right. Sources: The U.S. Coast Guard (left) and Cox Operating (right). Credit: NTSB
