UNITED STATES COAST GUARD

TUG VALOUR

40 MILES OFF THE COAST OF WILMINGTON, NORTH
CAROLINA ON JANUARY 18, 2006 WITH MULTIPLE
LOSS OF LIFE

Subj: TUG VALOUR REPORT OF INVESTIGATION

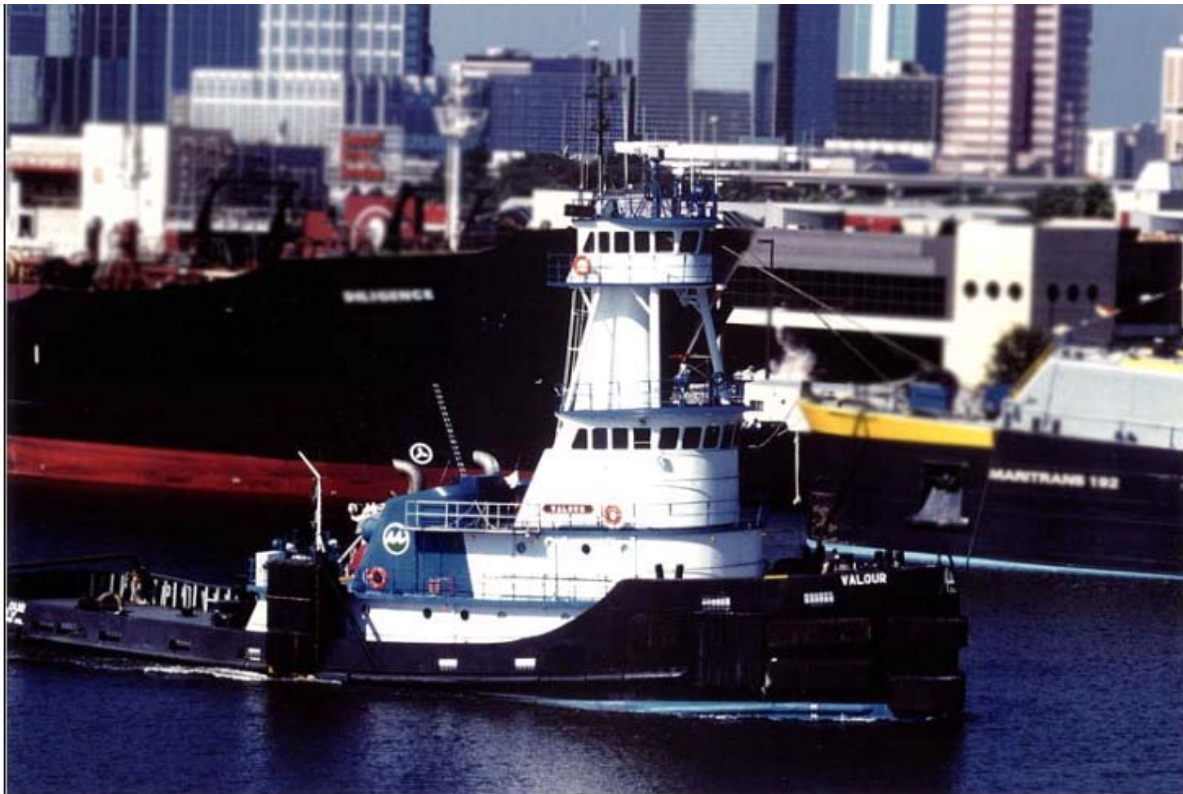
Photograph of the VALOUR prior to the incident

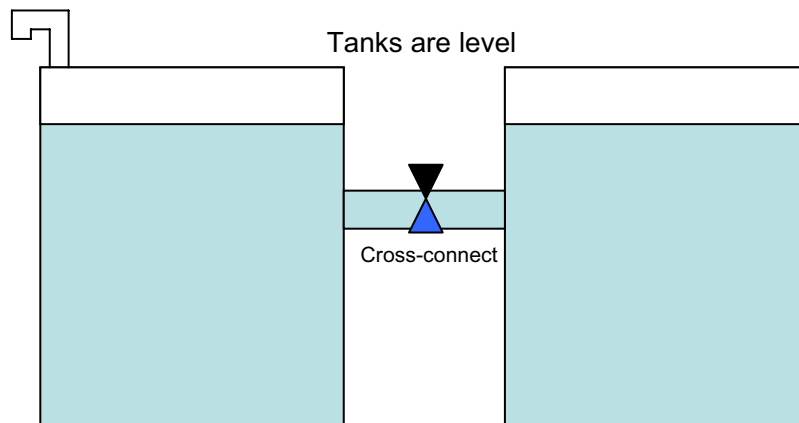
to approximately 6% of the permeable volume. Based upon the static angle of heel, limited righting energy, and submergence of the aft deck, the VALOUR would have had negligible stability and probably could not have stayed upright in the 12-20 ft seas reported at the time of the casualty. Once the VALOUR heeled over enough for continuous downflooding through the port engine room vents, sinking was inevitable. Determining the amount of time it takes for pairs of tanks to hydrostatically balance is difficult, especially taking into account the unknown but extreme vessel roll dynamics at the time of the casualty. However, assuming the difference in the fluid levels of the largest pair of tanks (#5 port and starboard fuel tanks) was 5 ft and the tanks were connected by a straight 10 ft section of 2.5 inch diameter pipe, the maximum initial flow rate would be approximately 210 gallons per minute. The modeling indicated that in balancing between successive conditions, a pair of tanks would need to transfer at most 2,700 gallons. Given the assumptions above, which are not exact to the actual conditions on the VALOUR, the balancing time would be at least 13 minutes. In practice it would take longer because of the differences in head pressure, piping diameters, piping configuration, the presence of multiple fittings, and the quantity of liquid to be transferred.
