Investigation Report 34/16

Serious Marine Casualty

Grounding of the CSCL INDIAN OCEAN in the River Elbe on 3 February 2016

14 October 2016

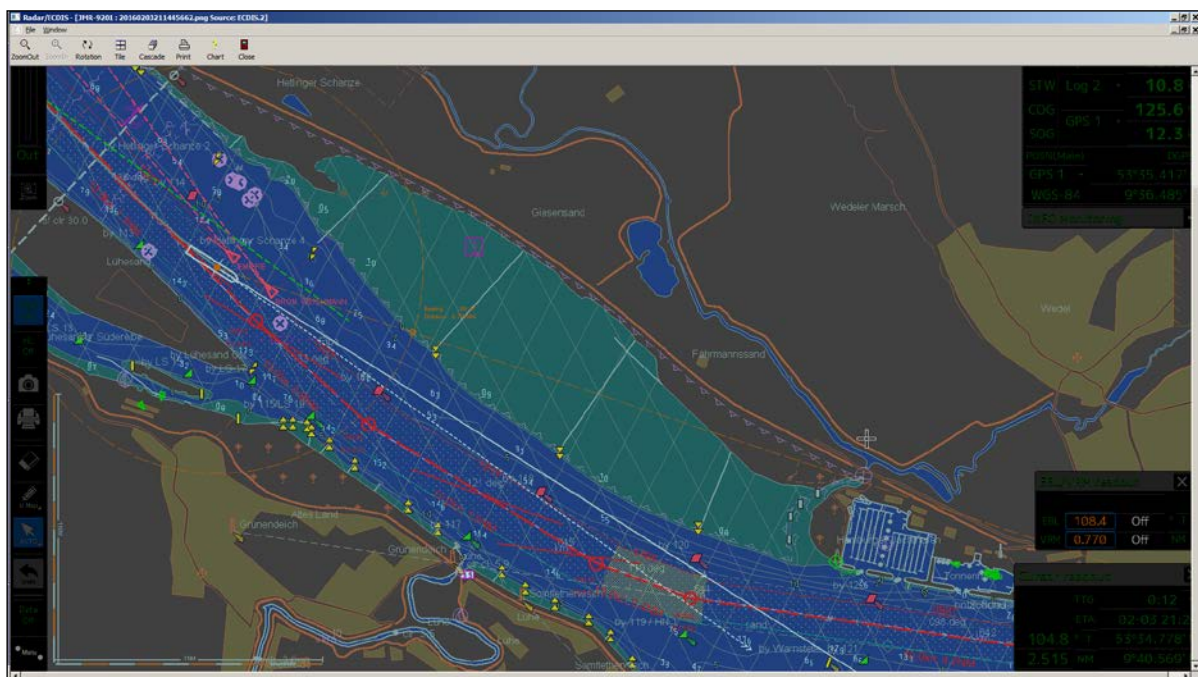
Figure 10: 221500 – helm responding again; oncoming traffic's closest point of approach

It can be heard at 2215 that the pilots are notified that the helm is responding again. Following that, the first pilot immediately advises HALF AHEAD and HARD TO STARBOARD. However, this manoeuvre had no significant effect. The speed has already dropped to $v = 12.5$ kts. The two oncoming vessels, MV EMPIRE and WSP boat BÜRGERMEISTER WEICHMANN, passed the CSCL INDIAN OCEAN on the port side at the same time.

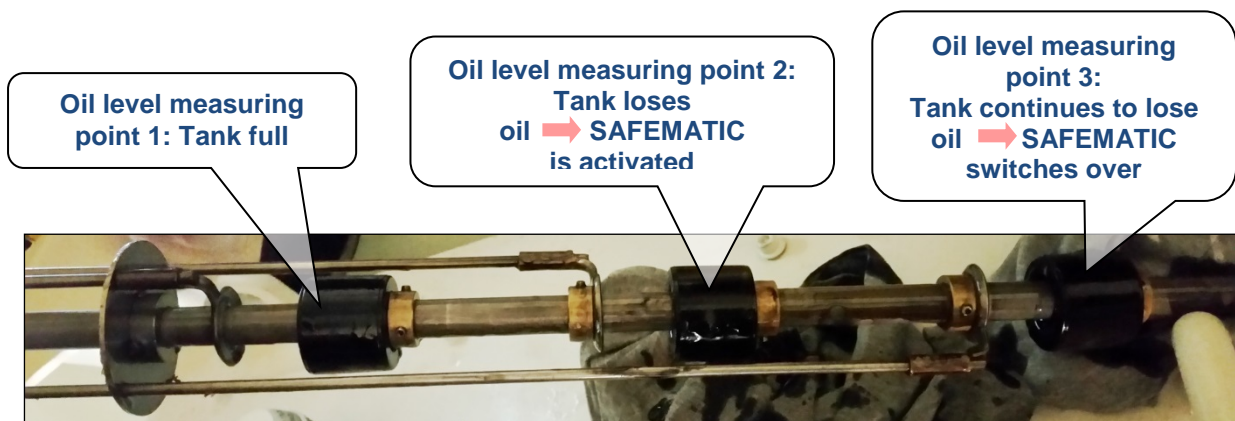
Figure 20: Removed float switch

Since there was no evidence whatsoever of any leakage, it is reasonable to assume that there was no leakage in the hydraulic system. From this point, a float switch malfunction would be conceivable. The expert disassembled and tested this completely on behalf of the BSU on 11 February 2016. Figure 16 shows the clean contact panel of the float switch. No faults were found, however. The float switch operated as it should.
