Report on the investigation of the
groundings of
Ocean Prefect
Umm Al Qaywayn, United Arab Emirates
on 10 and 11 June 2017

On 10 June 2017, the UK registered bulk carrier *Ocean Prefect* grounded when approaching Ahmed Bin Rashid Port, in Umm Al Qaywayn, United Arab Emirates. The vessel was not damaged and refloated 12 hours later with tug assistance. It then anchored in safe water. On 11 June, the vessel again touched the sea bottom when entering the port, but was able to continue to its berth. However, on this occasion, three of *Ocean Prefect*'s ballast tanks were breached, which required the vessel to dry dock in Dubai for repair. Two harbour pilots were on board during the groundings. There was no pollution and no injuries.

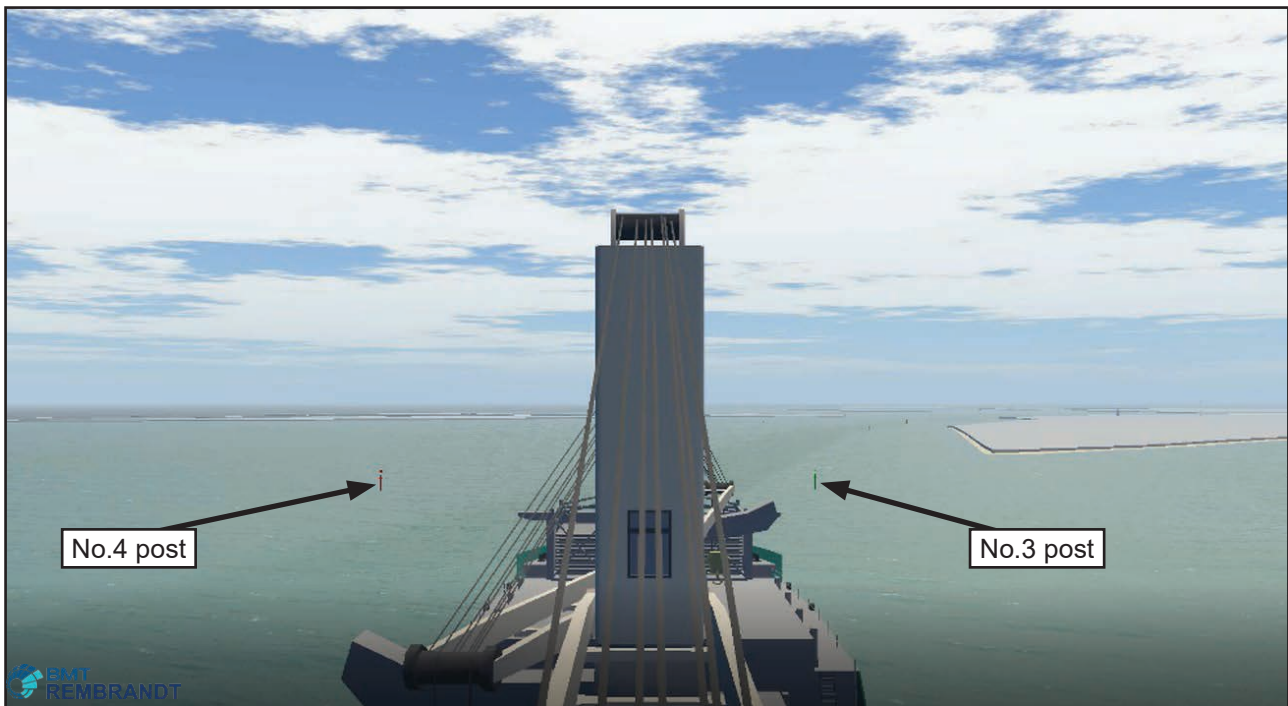
Figure 9: Simulated view from the bridge at 1300 (heading 155°)

It was not until 1258, following discussion with *Ocean Prefect*'s master about the set and being informed by the second officer that the course over the ground was 174°, that the pilot took more positive action. However, although he adjusted the vessel's heading to 155° followed by an increase in engine speed to 'slow ahead', *Ocean Prefect* remained between 50m and 75m to the west of the dredged channel. This does not appear to have been registered by the pilot, who was navigating solely by eye, or by the master, possibly because *Ocean Prefect*'s bow was now heading between No.3 and No.4 lateral posts (**Figure 9**).

Nonetheless, it is evident from the master's interventions regarding the vessel's set to the west soon after it had passed between No.1 and No.2 buoys, and the second officer's provision of radar information, that *Ocean Prefect's* bridge team did not allow the pilots to act in isolation. The master monitored the vessel's movement closely and continued to challenge the pilot about the set until the vessel's heading was altered to 155°. In this respect, the master's action accorded with the IMO and ICS guidance (paragraph 1.8). That he did not intervene and take the conn before the vessel grounded, which would have been an appropriate action in accordance with the vessel's SMS (paragraph 1.4.2), was because the pilot's actions to steer the vessel back into the dredged channel appeared to have been sufficient (**Figure 9**).
