**Australian Government**  
**Australian Transport Safety Bureau**

# Collision involving the bulk carrier Goliath and tugs York Cove and Campbell Cove, Devonport, Tasmania, on 28 January 2022

<b>Investigation number</b>	<b>Report release date</b>	<b>Report status</b>
MO-2022-002	22/03/2023	Final
<b>Investigation level</b>	<b>Investigation type</b>	
Defined	Occurrence Investigation

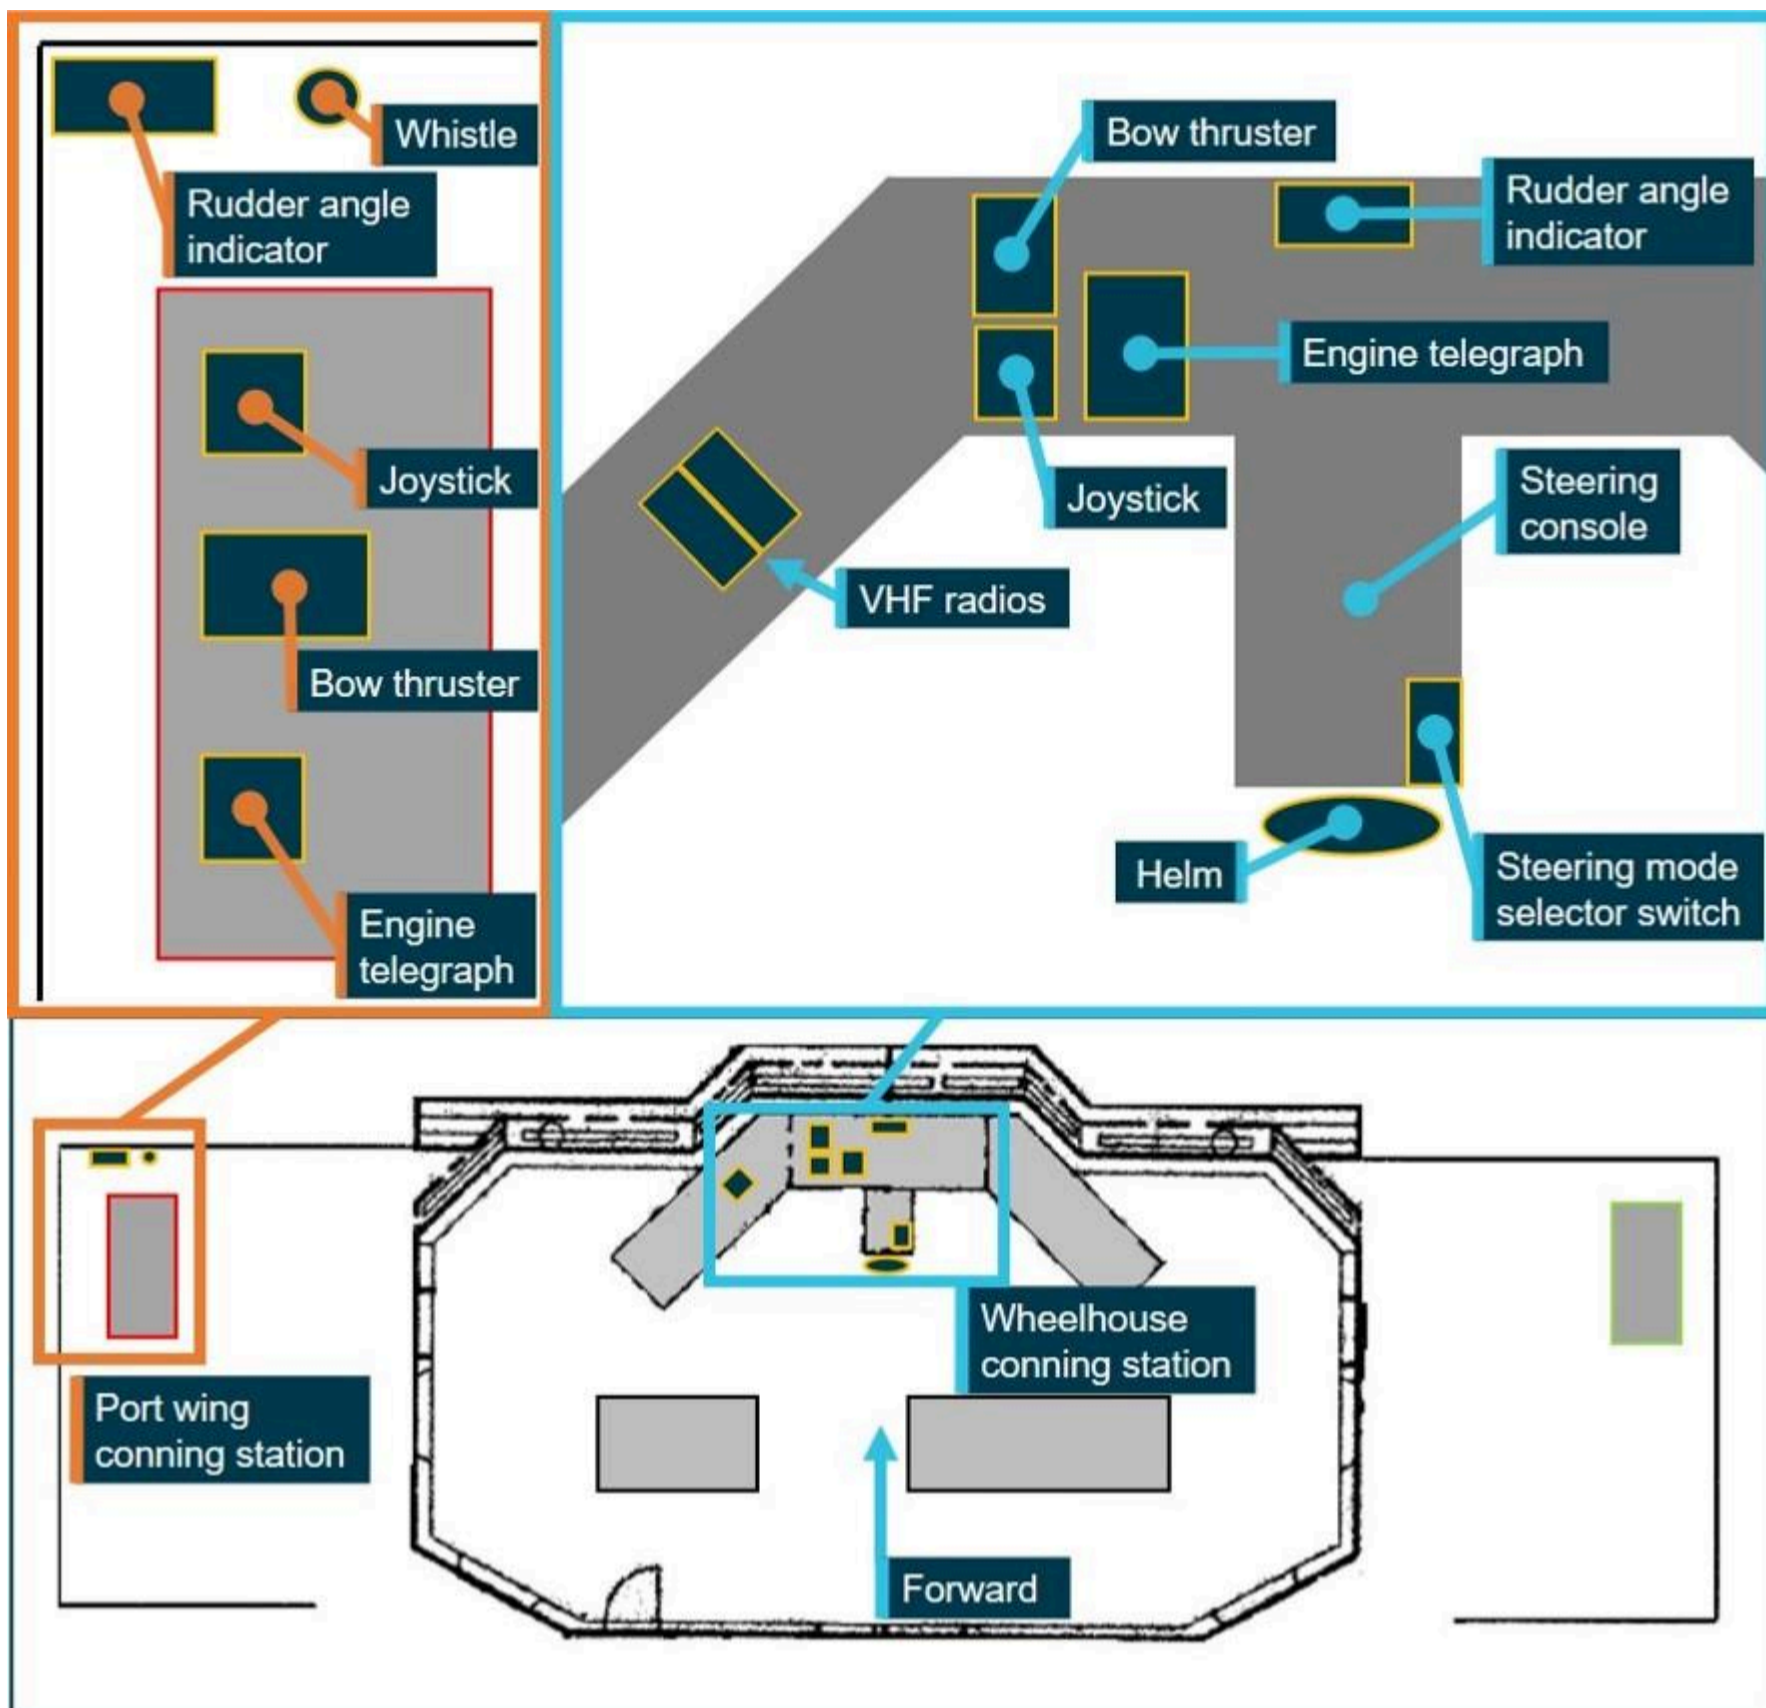
**Figure 3: *Goliath's* bridge layout showing the location of various controls and equipment**

At about 1140, the second mate came to the bridge with the intention of relieving the chief mate. The second mate and chief mate, situated to starboard of the steering console, began discussing the state of various ship's machinery, personnel, and bridge equipment. The helmsman was steering, and the master was stationed to port of the steering console where the main engine telegraph, bow thruster controls and VecTwin steering control joystick were located (see the section titled *Goliath's manoeuvring system* and Figure 3). By this time, the master had placed the telegraph on 'dead slow ahead' and shortly after, to 'stop'.

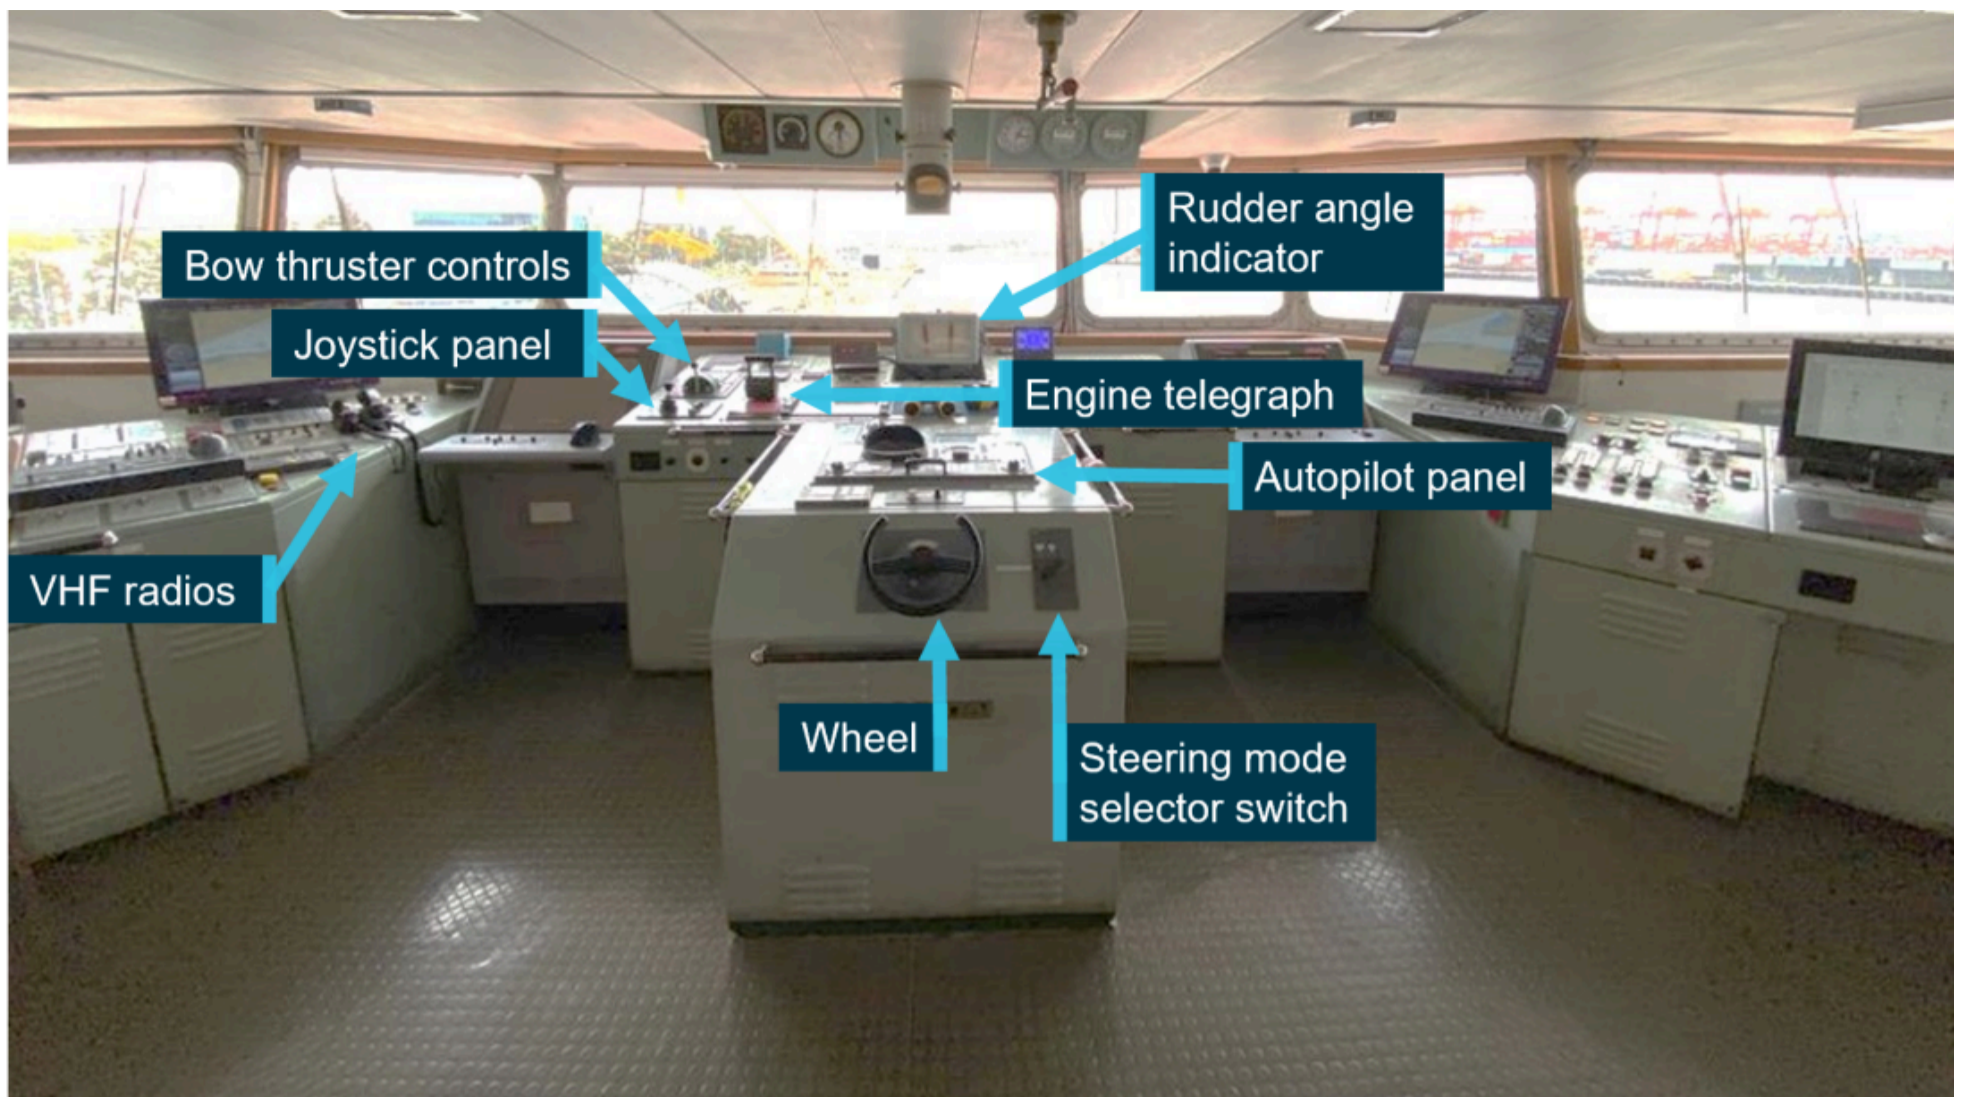
**Figure 4: *Goliath's* bridge showing location of various controls and equipment**

After a brief discussion with the master and chief mate about which radio to use, the second mate moved to the left of the master to use one of the 2 VHF radios located on the bridge-front console (Figure 4). One of those radios was generally used to maintain a listening watch on VHF channel 16<sup>[6]</sup> and the other to monitor working frequencies such as the port's working channel (in this case, channel 14). A portable VHF radio was normally reserved for berthing communications (channel 6).<sup>[7]</sup> The second mate acknowledged *Rubicon's* call on channel 14 and advised that the ship was standing by on channel 6.

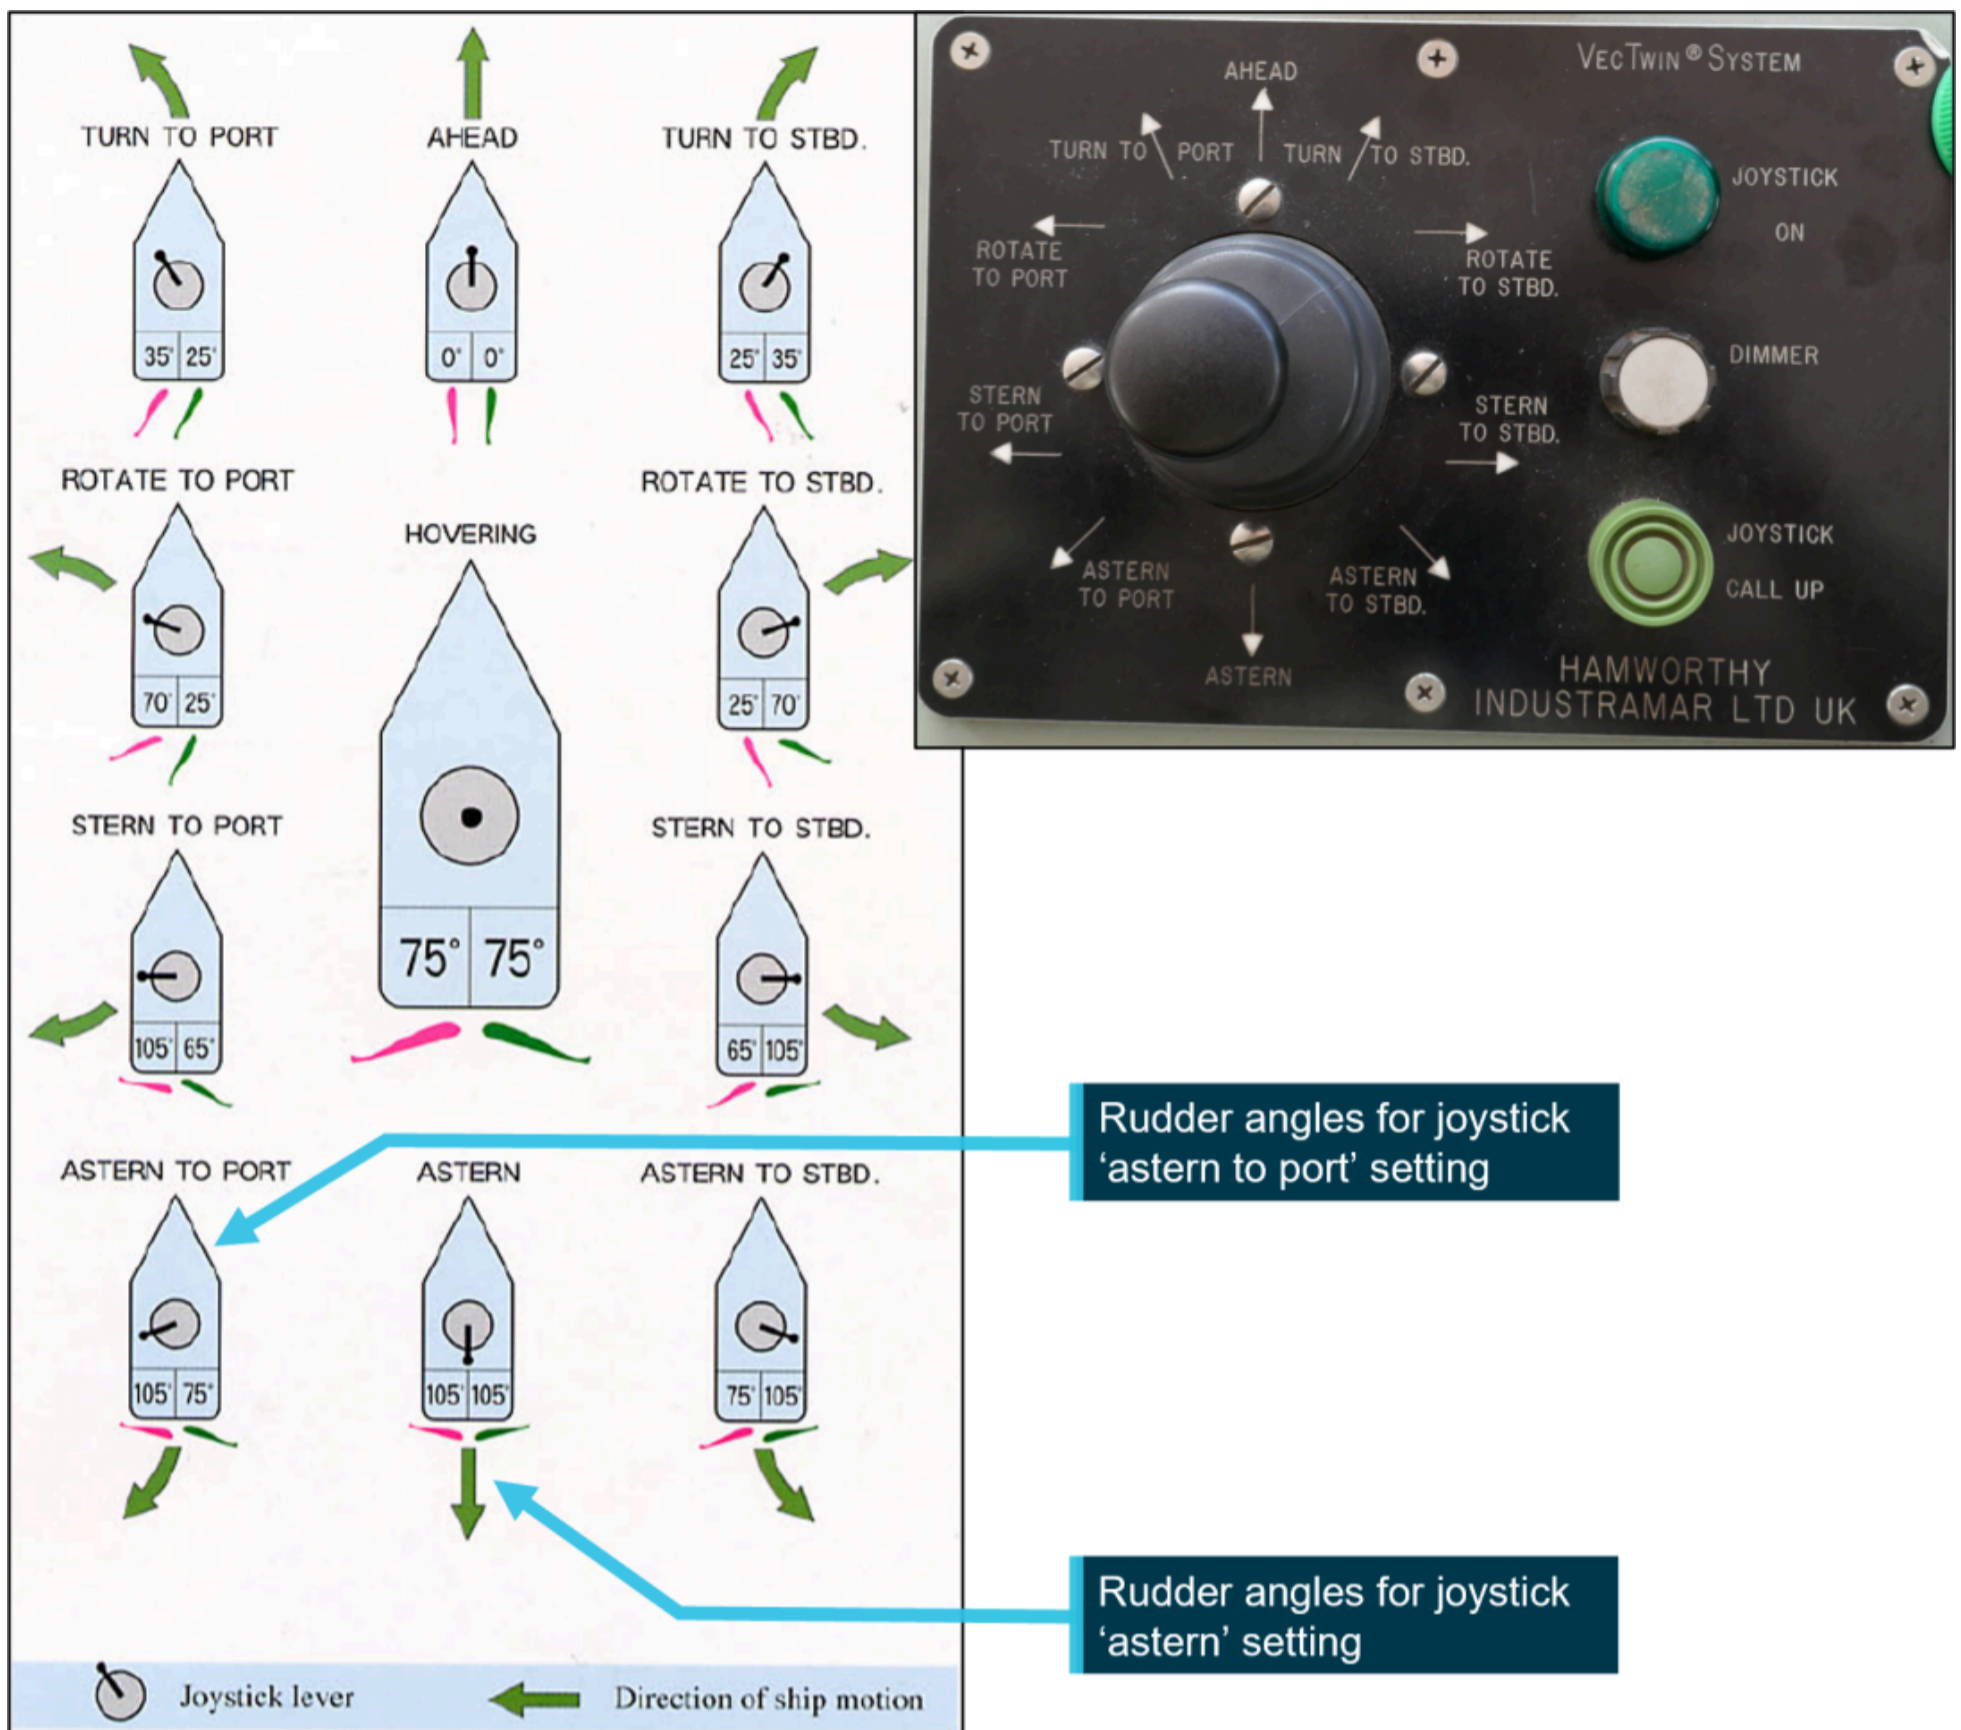
**Figure 12: VecTwin steering joystick showing settings and corresponding rudder angles**

In VecTwin (joystick) steering mode, a joystick was used to select various pre-set combinations of rudder angles which, with ahead inputs on the ship's main engine, allowed for the generation of thrust in different directions and for enhanced manoeuvrability, particularly at slow speeds. The system coordinated the 2 rudders independently with rudder angle settings ranging from 105° outboard to 25° inboard depending on the joystick setting selected (Figure 12). On board *Goliath*, VecTwin steering mode was generally only used at speeds under 2 knots, which generally limited its use to low-speed manoeuvring in port.

When using the VecTwin steering mode, ahead inputs on the main engine could be used to generate astern thrust, transverse thrust or even to 'hover', all with the propeller kept rotating in the ahead direction. For example, with the 'astern' joystick setting selected, each rudder was set to 105° outboard, with ahead inputs on the main engine generating astern thrust to slow/stop the ship or move the ship in the astern direction. This meant that the ship could be slowed, stopped, or moved astern without the need to stop the engine and engage astern propulsion, as usually required for conventional ship manoeuvring.
